## A Jammed Plate

By Chris Sharland (Shrimper 60, *Shellback*) (Spring 2010)

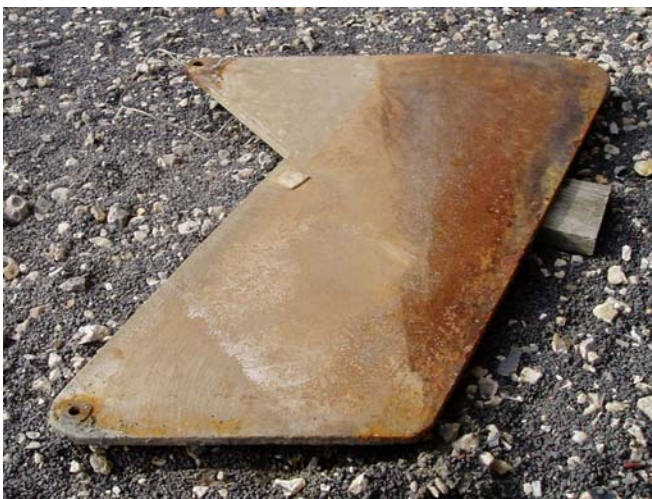
Most of this last sailing season, *Shellback* (60), built in 1981, has been sailed with only half a plate. Strangely this does not seem to have affected the boat's ability to sail to windward. However it was unsatisfactory not to be able to lower the plate completely.

When the boat came out of the water at the end of the season we put her under the hoist at Mengham Rythe SC and lowered the plate as far as it would go, which was about half-way, as expected. The plate was pressure-washed into the case from below and a saw blade run along either side of the plate. An amount of mud was removed and there seemed to be an obstruction someway aft of the centreboard bolt on either side of the plate. Still the plate could only be lowered half-way. Letting it go at the rush jammed the plate to such an extent that it had to be levered back using timbers on either side of the boat.

When I spoke to Cornish Crabbers they informed me that there were Tufnol blocks on both sides at the top of the plate, some way back from the swivel bolt. The aim of this was to stop the plate moving sideways in the slot. However, some 12 years ago they stopped fitting the blocks. For the first time in all the years I have owned my Shrimper, I was forced to seek professional help and went to the boat yard next to the club. The boat was lifted by crane and, with some difficulty, the plate was removed.

The first photo shows the plate having been in the boat since 1981. Considering this length of time, the plate was not in too bad a state. The Tufnol blocks can be seen aft of the pivot hole.
