## *Centreboard case distortion in Cornish Shrimper No. 124*

*Robin Whittle*

No 124: Bumble Chugger (BC) was built in 1983.

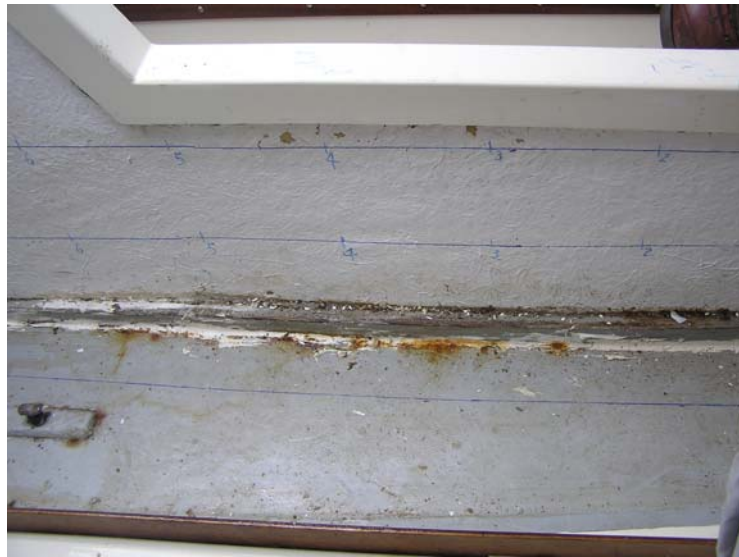
After some thought during the winter months when BC was laid up I considered the possibility that the centreboard case was being squeezed by the ballast. I removed the floorboards to examine the ballast for any signs of movement. A crack had opened up along the starboard side of the centreboard case. It varied from 2 to 4 mm wide and had caused the strip of wood which supports the floorboard to separate from the centreboard case over a length of about 500 mm.

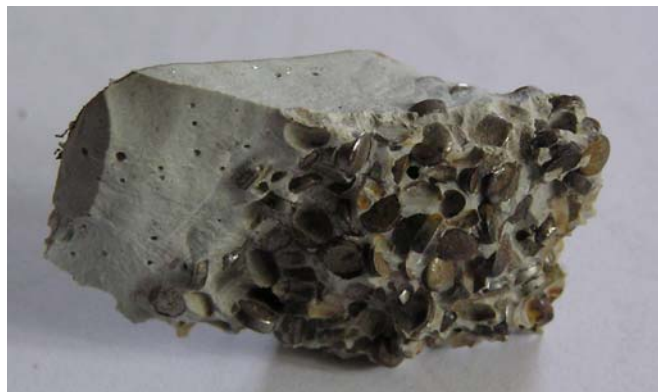
I discovered from discussion with Cornish Crabbers Ltd (now Select Yachts) that the ballast is made up of steel pressings set in a compound of slate dust and polyester resin. In BC each pressing is about 3 mm diameter and 1 mm thick. Several million of these pressings are used to make up the volume of ballast

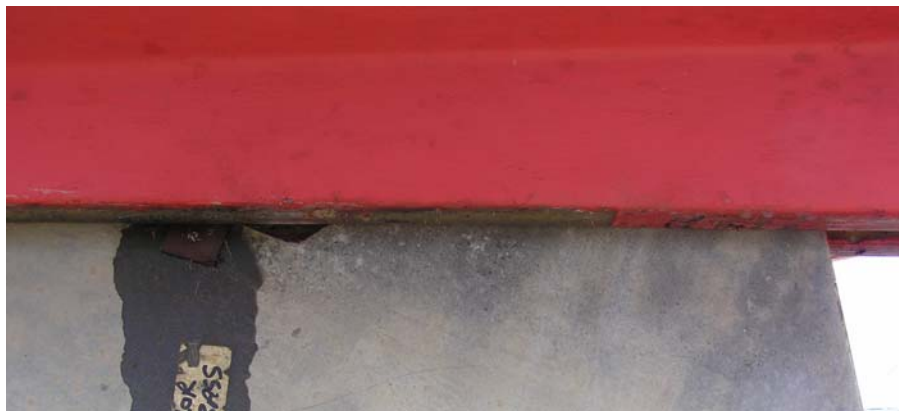
During this operation the centreboard was moved sufficiently to allow a visual check inside the centreboard case. A bulge could be seen on the starboard side.

BC was placed on the cradle at the Felixstowe Ferry Boatyard again at Easter, 2004 (9/10 April) and the centre board was lowered to remove the tuffnel blocks. At the same time I tried to remove the centreboard altogether. This was not possible. At the hinge point a collar passes through the centreboard and projects out each side by 2 mm (approx.). It was this collar that jammed on the centreboard case and prevented it from being removed. I replaced the centreboard to its inboard position and confirmed that it was free to be raised and lowered without jamming.

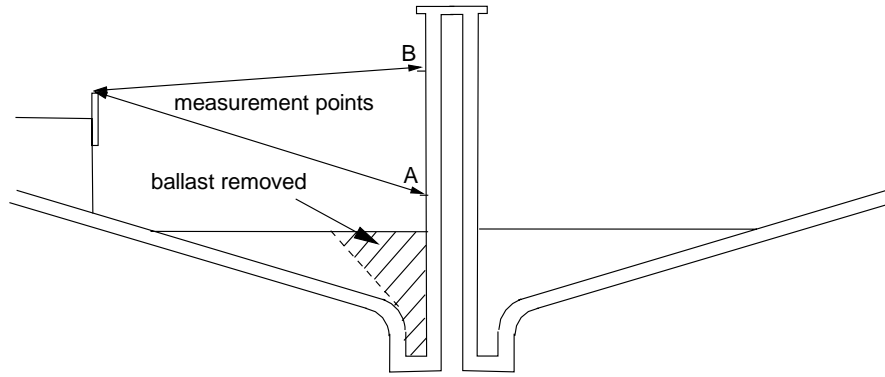
**Figure 1: Section through hull showing the ballast removed**

During the summer the centre board remained free to move up and down until mid-August, when it started to stick again. This suggested that the bulge had increased during this time. I decided to replace a strip of ballast 4 inches wide adjacent to the starboard side of the case (see Figure 1). Before I started work I checked the position of the centreboard case by taking measurements from the top of the bunk lath to a series of eight points at two levels 'A' and 'B'.

The pressed steel cuttings separated from the ballast compound and flew out in a yellow/red hot state, burning holes in my paper overalls. Once the saw cuts had reached about 50 mm deep I used the hammer and cold chisels to remove the bulk of the ballast.

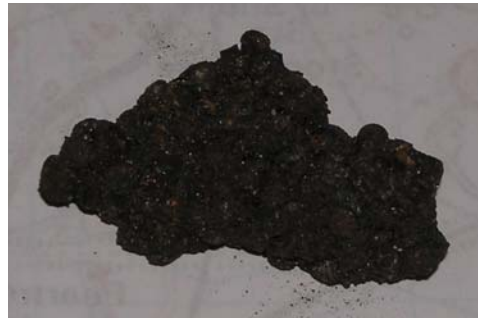
Close to the centreboard case there were patches where the steel pressings had rusted and formed a clinker.

This clinker had formed expanding struts which had caused the centreboard case to be squeezed. In one place there was a void in the ballast about 50 mm long, 20 mm wide and high but the steel pressings around its surface had surprisingly not rusted.

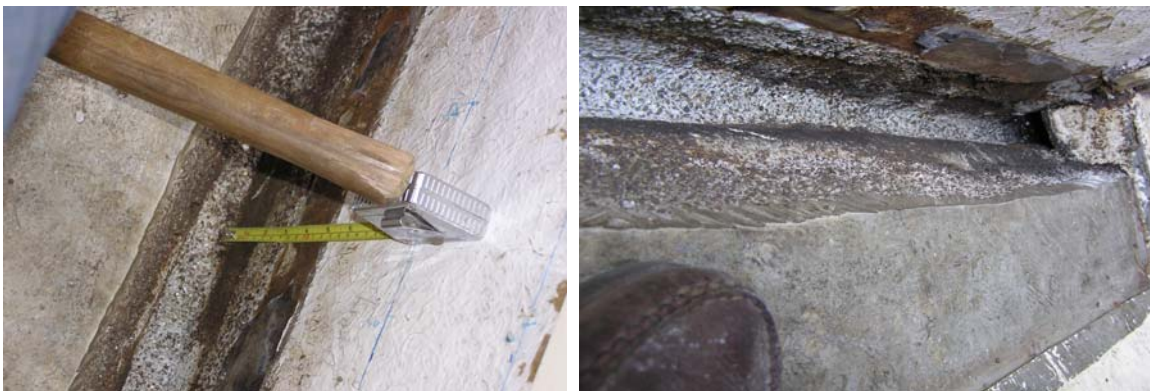
Contrary to my first expectations the rusting had not spread from the rear end of the centreboard case. Although the plywood bulkhead at that end had been distorted by the expansion of the ballast, the steel pressings close to the centreboard case were not rusty. Rusty areas close to the centreboard case appeared to be randomly placed, possibly related to how dense the ballast mix had been.

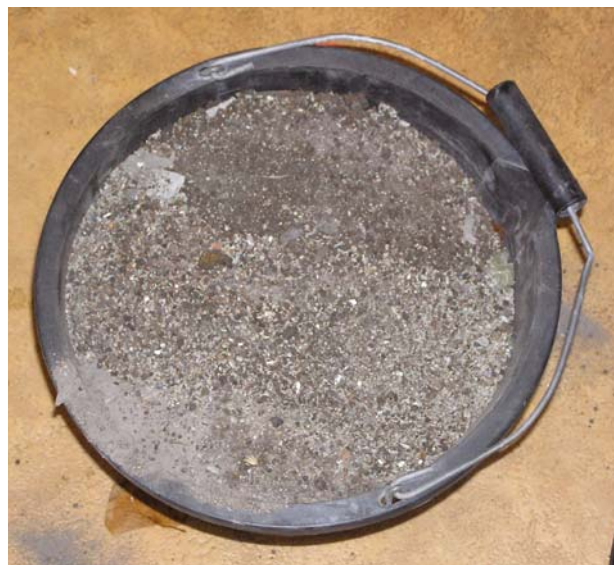
In total I removed 6 stone (38 kg) of ballast. The volume of this filled a plastic bucket.

I replaced the ballast with 4½ stone (29 kg) of lead. This was melted down and poured over a paving stone to produce thin flat sheets. I have to admit an appalling accident during this operation. I had been using a specially bought saucepan for melting the lead which was done by heating it up on our gas cooker! A particularly large piece of lead was precariously balanced in the saucepan and slowly melting from the bottom up. I took my attention off it, for just a moment, and of course disaster occurred. The lead had slowly tipped over as it melted and the saucepan lost its balance!! The whole lot, including a considerable amount of molten lead then fell over towards me. I was just quick enough to jump out of the way to avoid being burnt - but the vinyl floor wasn't so nimble!!! Gillie was not best pleased. The outcome was that I had to lay a new kitchen floor.
