A Report Of The Examination Of Yanmar 1GM10 Diesel Engine Exhaust Ejector Elbows

By Mike Hill, Shrimper 372 *Veronica* (2003)

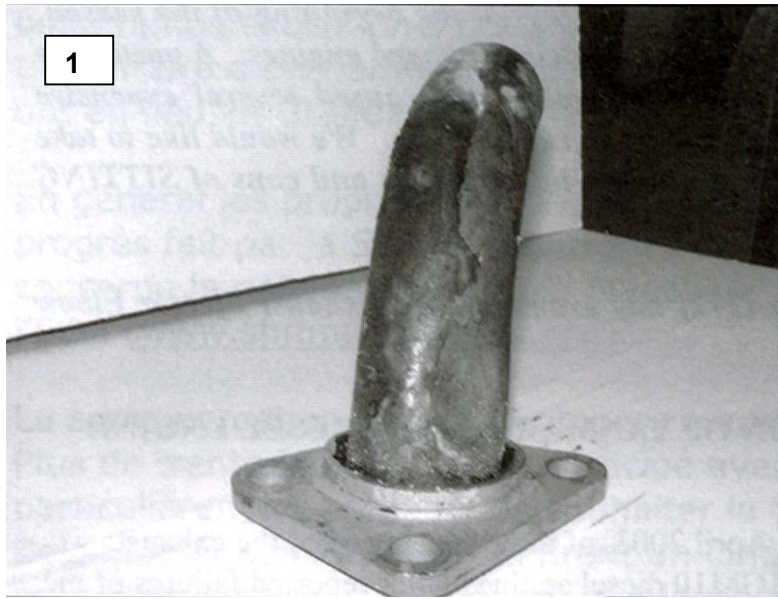
Picture 1 shows the inner tube of the annulus with a distinct "tide mark" of iron oxide and general local corrosion. This tidemark would seem to indicate the level of cooling water that remains in the annulus when the diesel engine is static.

During operation of the diesel engine the porosity of the exhaust tube should not present a problem. However, once at rest and given the level of static water indicated by specimen 2, particularly during lay up periods, salt water can freely permeate into the engine via the exhaust port. The resulting corrosion to the cylinder head and generally to the engine internals under these conditions is obvious.

Because the removal of the exhaust ejector elbow is a relatively simple task, it is recommended that it be removed at least once a year for examination and test for corrosion and or porosity.

It is further recommended that a strict procedure is adopted at time of lay up to remove

as much salt water as possible by means of flushing with fresh water and then application of an antifreeze corrosion inhibitor.

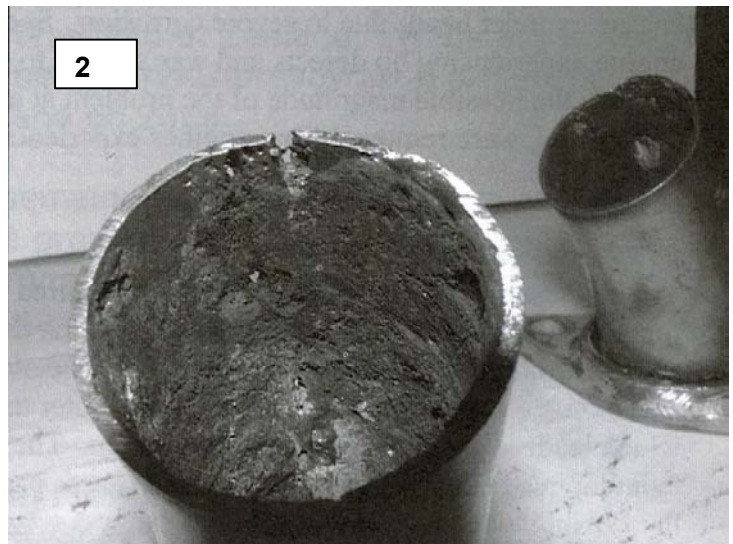
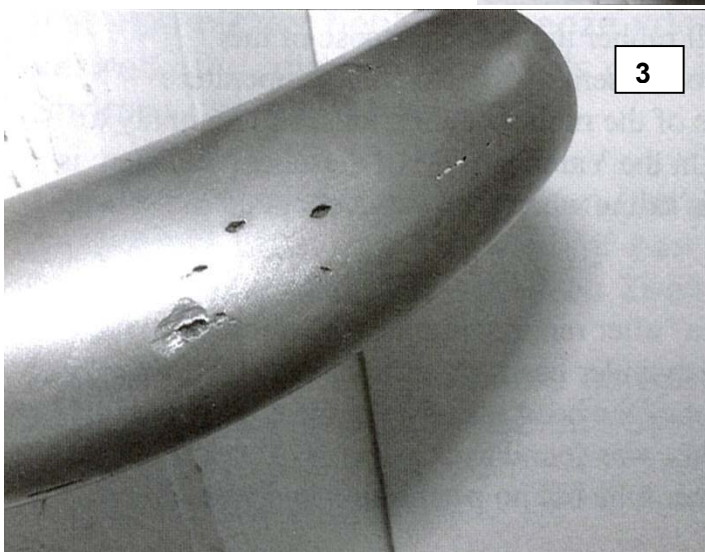
Pictures 2 and 3 are of the same specimen, sectioned and polished. It can be clearly seen that this tube is severely corroded internally and externally to the extent that it has become porous. Any water present in the annulus would be free to pass into the exhaust tube.

It is felt that the manufacture of these exhaust ejector elbows is carried out using a low-grade stainless steel containing inclusions of free iron within the material, implicit with such a choice of material. (This grade of material can be quite commonly seen on poor quality deck fittings exhibiting what appears to be "rust" staining). These impurities are reacted upon by a combination of salt water and the exhaust gases from the diesel engine, resulting in "corroding out" of the iron, leaving voids and holes in the parent material.

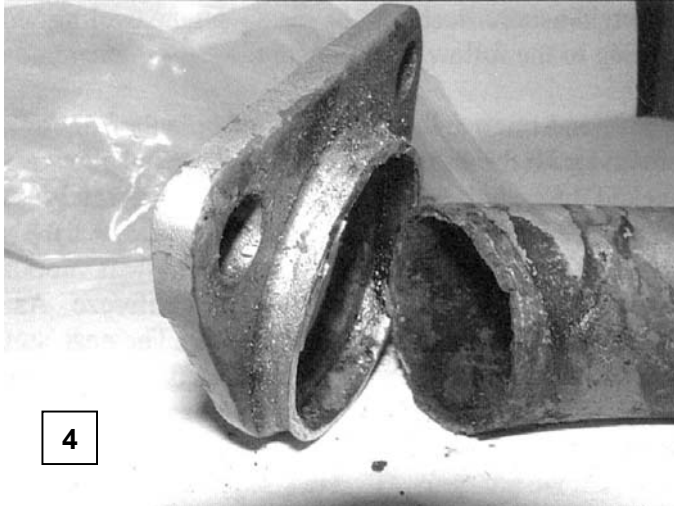
Picture 4 shows the inner tube, which had become completely detached from the flange due to severe corrosion of the weld metal. The exhaust tube itself showed signs of corrosion similar to specimen 2. Here water would be able to contaminate the engine internals, via the failed weld, immediately the engine was stopped.
