# **A Report Of The Examination Of Yanmar 1GM10 Diesel Engine Exhaust Ejector Elbows**

By Mike Hill, Shrimper 372 *Veronica* (2003)

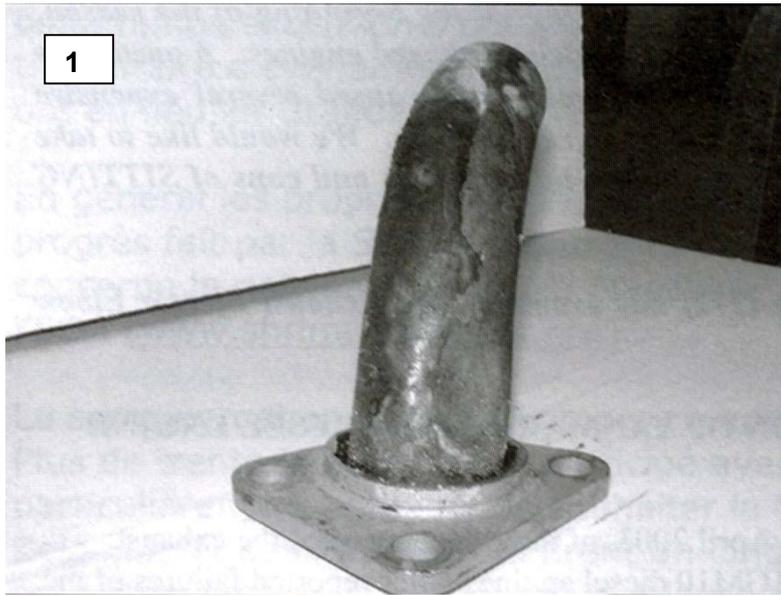
Picture 1 shows the inner tube of the annulus with a distinct "tide mark" of iron oxide and general local corrosion. This tidemark would seem to indicate the level of cooling water that remains in the annulus when the diesel engine is static.

During operation of the diesel engine the porosity of the exhaust tube should not present a problem. However, once at rest and given the level of static water indicated by specimen 2, particularly during lay up periods, salt water can freely permeate into the engine via the exhaust port. The resulting corrosion to the cylinder head and generally to the engine internals under these conditions is obvious.

Because the removal of the exhaust ejector elbow is a relatively simple task, it is recommended that it be removed at least once a year for examination and test for corrosion and or porosity.

It is further recommended that a strict procedure is adopted at time of lay up to remove

as much salt water as possible by means of flushing with fresh water and then application of an antifreeze corrosion inhibitor.

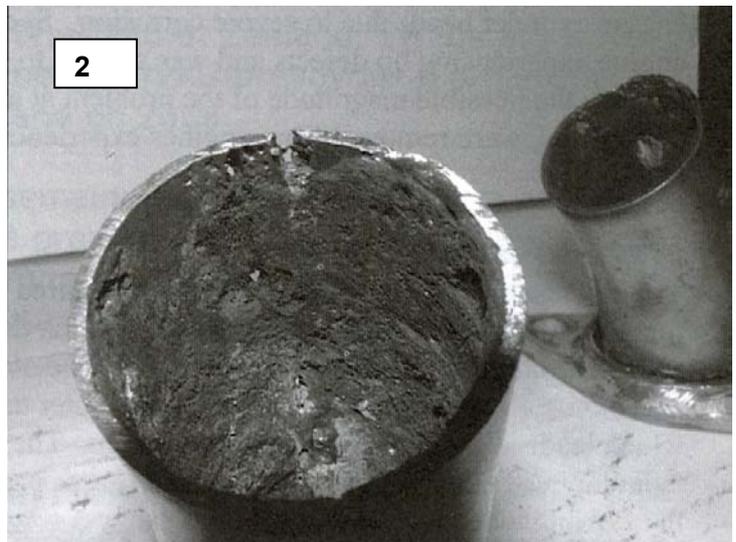
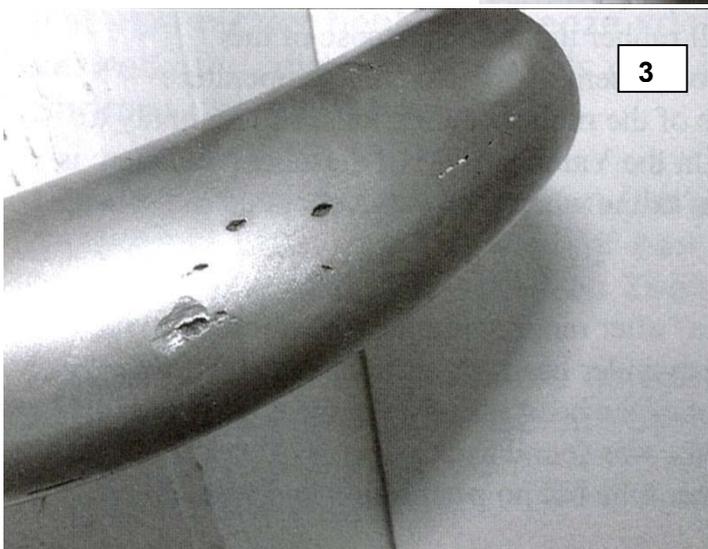
Pictures 2 and 3 are of the same specimen, sectioned and polished. It can be clearly seen that this tube is severely corroded internally and externally to the extent that it has become porous. Any water present in the annulus would be free to pass into the exhaust tube.

It is felt that the manufacture of these exhaust ejector elbows is carried out using a low-grade stainless steel containing inclusions of free iron within the material, implicit with such a choice of material. (This grade of material can be quite commonly seen on poor quality deck fittings exhibiting what appears to be "rust" staining). These impurities are reacted upon by a combination of salt water and the exhaust gases from the diesel engine, resulting in "corroding out" of the iron, leaving voids and holes in the parent material.

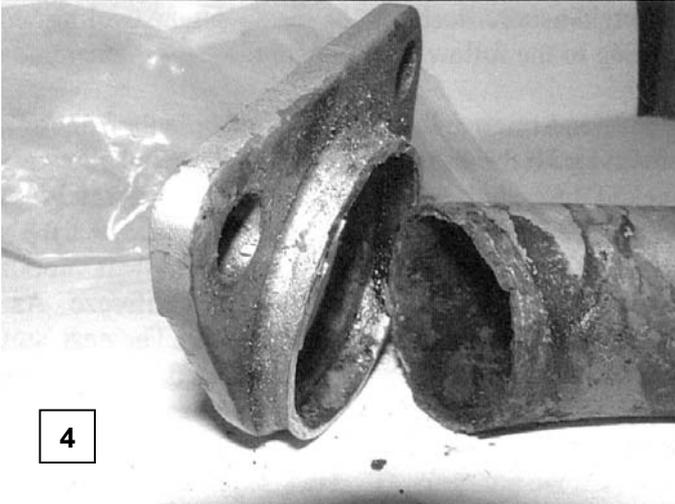
Picture 4 shows the inner tube, which had become completely detached from the flange due to severe corrosion of the weld metal. The exhaust tube itself showed signs of corrosion similar to specimen 2. Here water would be able to contaminate the engine internals, via the failed weld, immediately the engine was stopped.
