Mast Maintenance & Repair

By Keith Thatcher, Shrimper *Winkle* (144), SOA Technical Web Sec (March 2011)

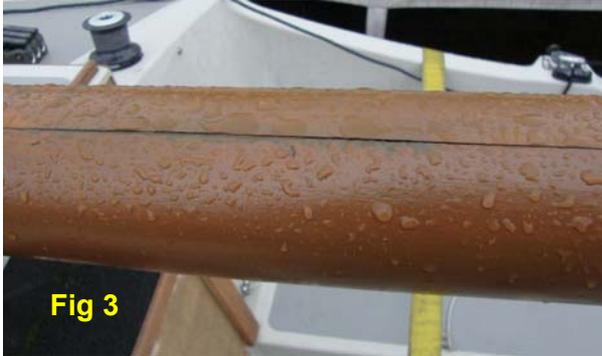
Fig 3

All joints are glued using a high quality marine grade adhesive, commonly resorcinol (Phenol Formaldehyde resin), which moves and flexes with the wood and can be identified by a red joint line. Other adhesives are also used, so don't worry if the joints on your mast are not red. Used correctly, these glues have excellent durability, but can occasionally suffer bond failure in the surrounding timber if it is allowed to become wet over long periods. This is usually the result of hairline cracks in the coating along the glue line allowing water to penetrate the timber. It is therefore essential to check all glue joints for sign of weathering discolouration. Caught quickly, a quick clean back to bare wood and local recoating should be all that is necessary to prevent further problems, but the area should be allowed to dry out before recoating.

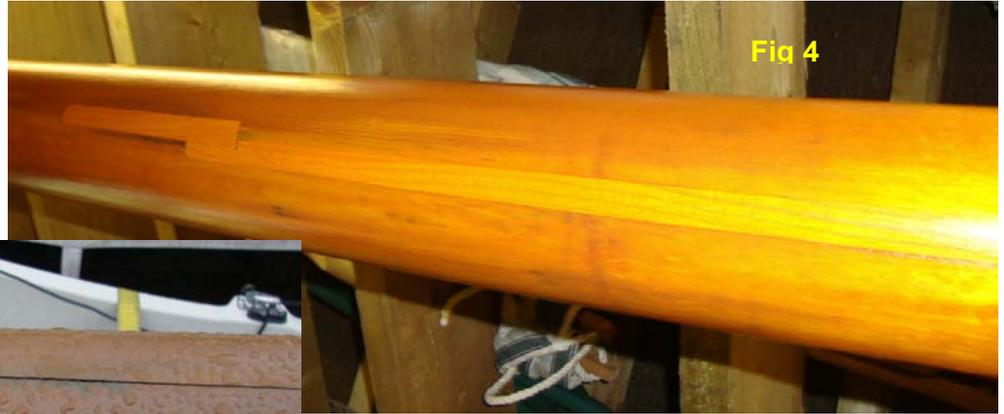
Fig 4

Re-gluing a severely delaminated joint is not advisable and, in most cases, impossible without taking the whole assembly apart. Not only do you have the difficulty of getting a thixotropic liquid into a narrow crack, but the adhesive needs to penetrate the wood pores to bond effectively and any old hardened glue effectively seals the surface. It is therefore important to seek professional advice when determining the repair potential for any glue line fault, particularly one as bad as that shown in Figs. 1 & 2. However, small areas of joint separation, similar to that shown in Fig 3, can be repaired, if not too deep, by cleaning out the damaged area to sound wood using a router and gluing in new timber. A typical repair of this type is shown in Fig. 4.

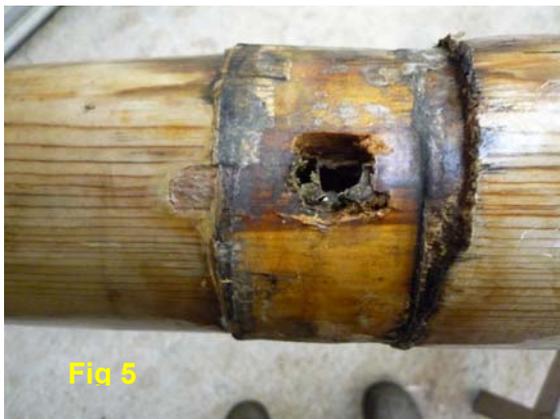
Fig 5

Digging out and patching small areas with a polyester resin filler can provide some respite, but rarely works for long as the timber and filler have different flexibilities. The best way to repair small areas of softened timber found in the outer surface of the mast or extending a short way into the bolt hole is to cut out the damage and glue in a suitably sized piece of new wood. If necessary, the band can be refitted and used as a template to re-drill the bolt hole. Anything more serious, as shown in Figs. 5 & 6, will require more drastic measures (in this case a whole new top section!). Notice how the enlarged bolt hole has allowed the band to move and distort the shoulder on the opposite side.
