# Mast Maintenance & Repair

By Keith Thatcher, Shrimper *Winkle* (144), SOA Technical Web Sec (March 2011)

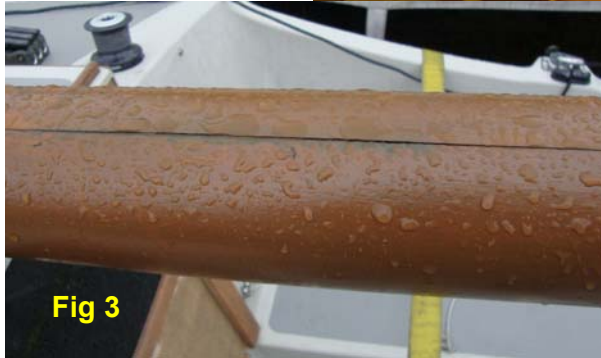
Fig 3

All joints are glued using a high quality marine grade adhesive, commonly resorcinol (Phenol Formaldehyde resin), which moves and flexes with the wood and can be identified by a red joint line. Other adhesives are also used, so don't worry if the joints on your mast are not red. Used correctly, these glues have excellent durability, but can occasionally suffer bond failure in the surrounding timber if it is allowed to become wet over long periods. This is usually the result of hairline cracks in the coating along the glue line allowing water to penetrate the timber. It is therefore essential to check all glue joints for sign of weathering discolouration. Caught quickly, a quick clean back to bare wood and local recoating should be all that is necessary to prevent further problems, but the area should be allowed to dry out before recoating.

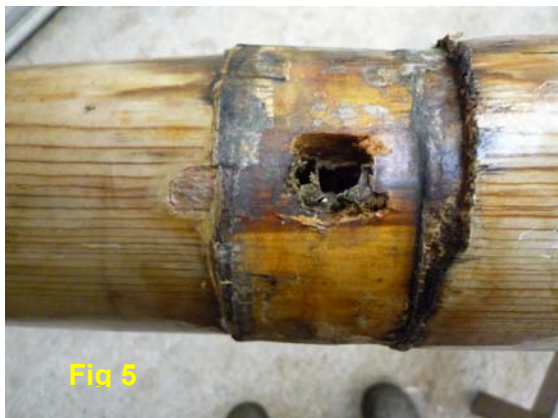
Fig 5

With the band removed, look for peeling varnish, discolouration or softness of the wood around the hole using a small screwdriver or spike to determine the full extent of the damage. Remember that for an effective repair all the decayed timber needs to be removed or the problem will be back within a few years. The band transfers all the rigging loadings into the mast and the only things keeping it in place are the bolt and the shoulder machined into the mast below. Any sloppiness in the bolt hole could allow the band to slip or twist to one side, altering the effective length of shroud causing the mast to lean.

Digging out and patching small areas with a polyester resin filler can provide some respite, but rarely works for long as the timber and filler have different flexibilities. The best way to repair small areas of softened timber found in the outer surface of the mast or extending a short way into the bolt hole is to cut out the damage and glue in a suitably sized piece of new wood. If necessary, the band can be refitted and used as a template to re-drill the bolt hole. Anything more serious, as shown in Figs. 5 & 6, will require more drastic measures (in this case a whole new top section!). Notice how the enlarged bolt hole has allowed the band to move and distort the shoulder on the opposite side.
