# Mast Support Repair

By John Bengé, Shrimper 433 (2002)

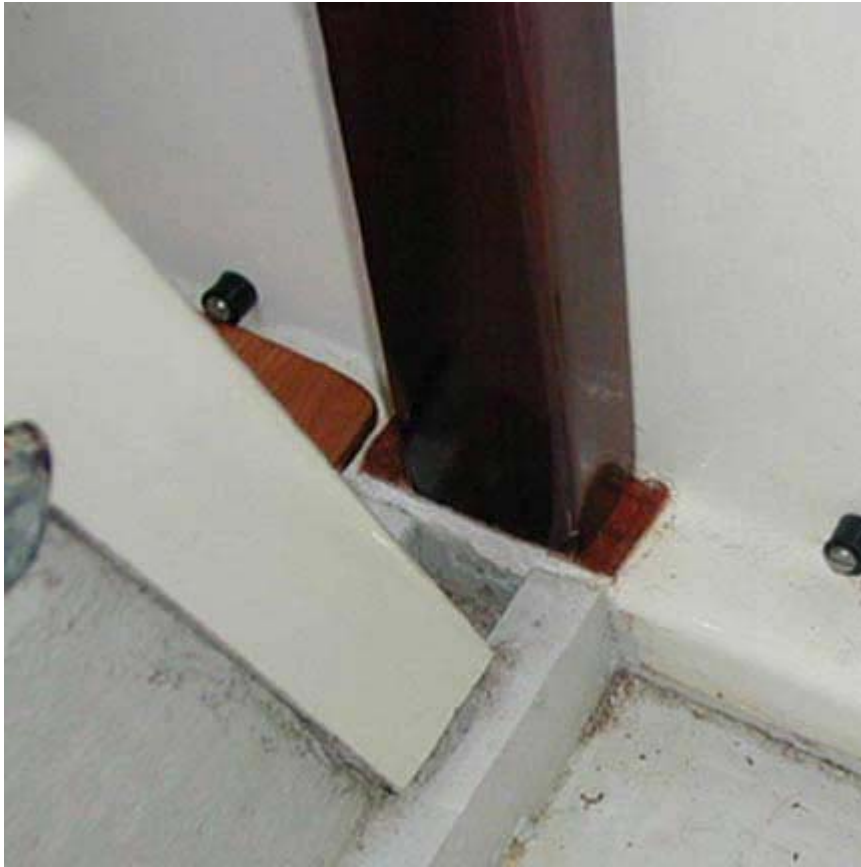
In this case the moulding was very badly damaged, having broken away under the post.

The hardwood support block was therefore extended up to fit the opening where the damaged moulding had been cut out. The block was made to the original level. By using fastenings to the block it was lowered into position through the galley top small access hole and pulled up tight to the correct level. Resin and chopped matting were then poured in from the top, thus obviating the necessity of a further access hole in the internal galley moulding. Finally, sealant was applied to the small gap between the hardwood and the moulding.
