Mast Support Repair

By John Bengé, Shrimper 433 (2002)

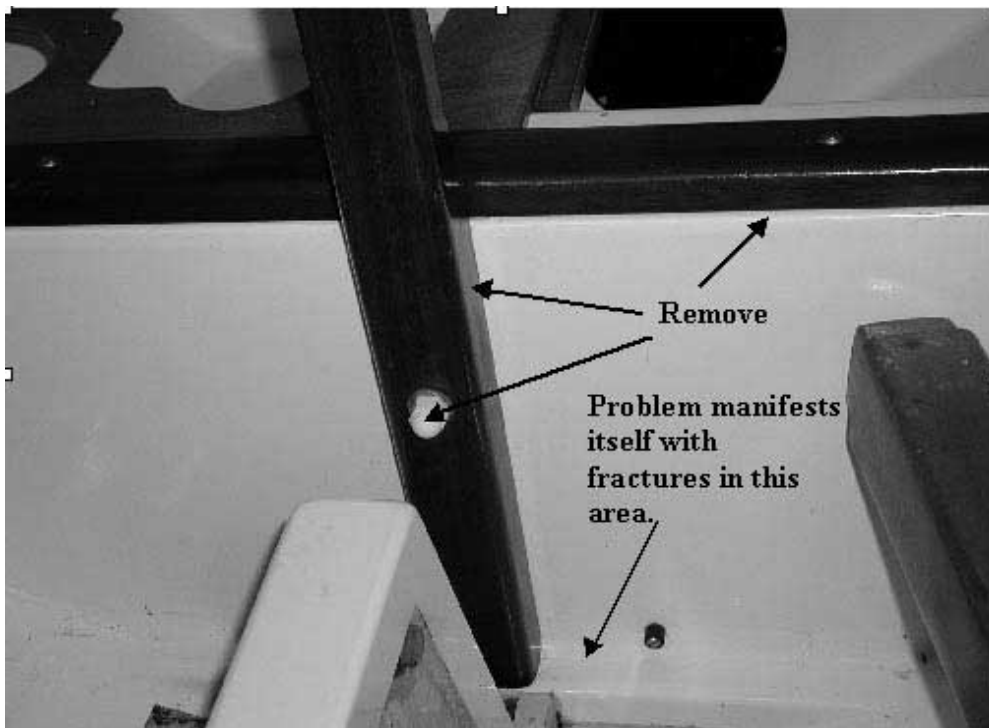
On many older boats defects have developed over time with the mast support arrangements. The wooden vertical post at the forward end of the cabin (located at its upper end within a "cut out" wooden block screwed to the deck and at its lower end the cabin sole) moves down and fractures the internal moulding at its base.

The function of this support post is to transmit mast loadings down to the internal ballast and keel. Unfortunately, on some boats, there was no blocking arrangement fitted between the cabin moulding and the internal ballast. Therefore the post securing bolt to the galley bulkhead and the internal moulding, which is around 5mm thick, took the load. Ultimately, with the resultant downward deck deflection, trouble may also be experienced with the main hatch opening and closing.

1. Remove mast. The repair must be carried out with the mast removed.

2. Remove post top locating wooden section, 4 screws.
3. Remove thwartships wooden cap rail fitted along the top of the galley moulding, 4 or 5 screws. A small hole to the post bolt nut is now accessed.
4. Undo the post/bulkhead bolt and nut and remove the support post.
