## Re-Engineering a Shrimper Mast Collar

By Rod Young, Shrimper 619 (*Topaz*), (August 2010)

## Technical Comment – Mast Band

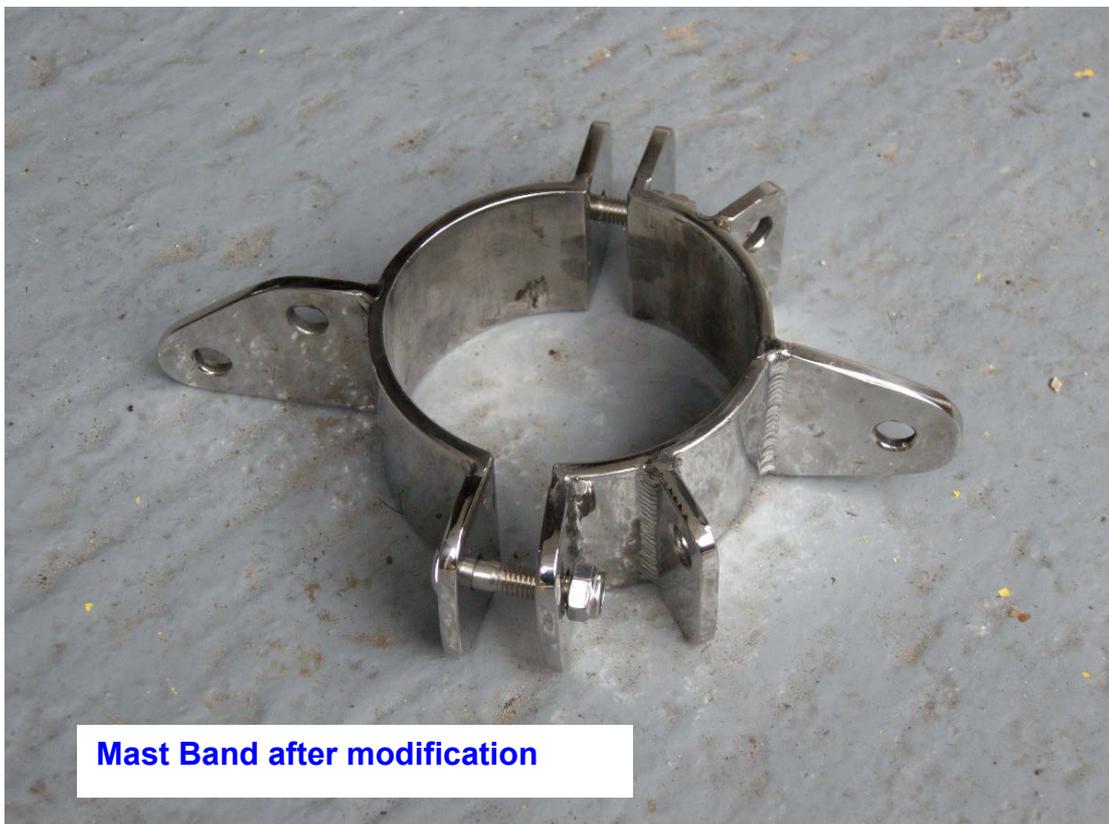
**Mast Band after modification**

Nick was familiar with the problem, and explained that, because the mast collar was secured to the mast with a stainless steel through-bolt, water could penetrate around the bolt. Unless the hole through the mast was unusually well protected when new, the eventual outcome was inevitable. His advice was to re-engineer the collar to do away with the need for a bolt. The existing collar should be cut through on each side of the bolt-holes, and flanges welded on to the four cut edges. The flanges could then be drilled for stainless steel bolts, and, instead of bolting through the mast, the collar could be clamped on.

A local steel fabricator took on the job, at a cost of around £60. As the photos show, the result looked good, and the collar clamped neatly into place. It has not budged so far, and I need not worry about my smart new mast rotting as the old one did. I recommend the solution to other Shrimper owners, preferably before rot sets in and an expensive new mast becomes necessary.

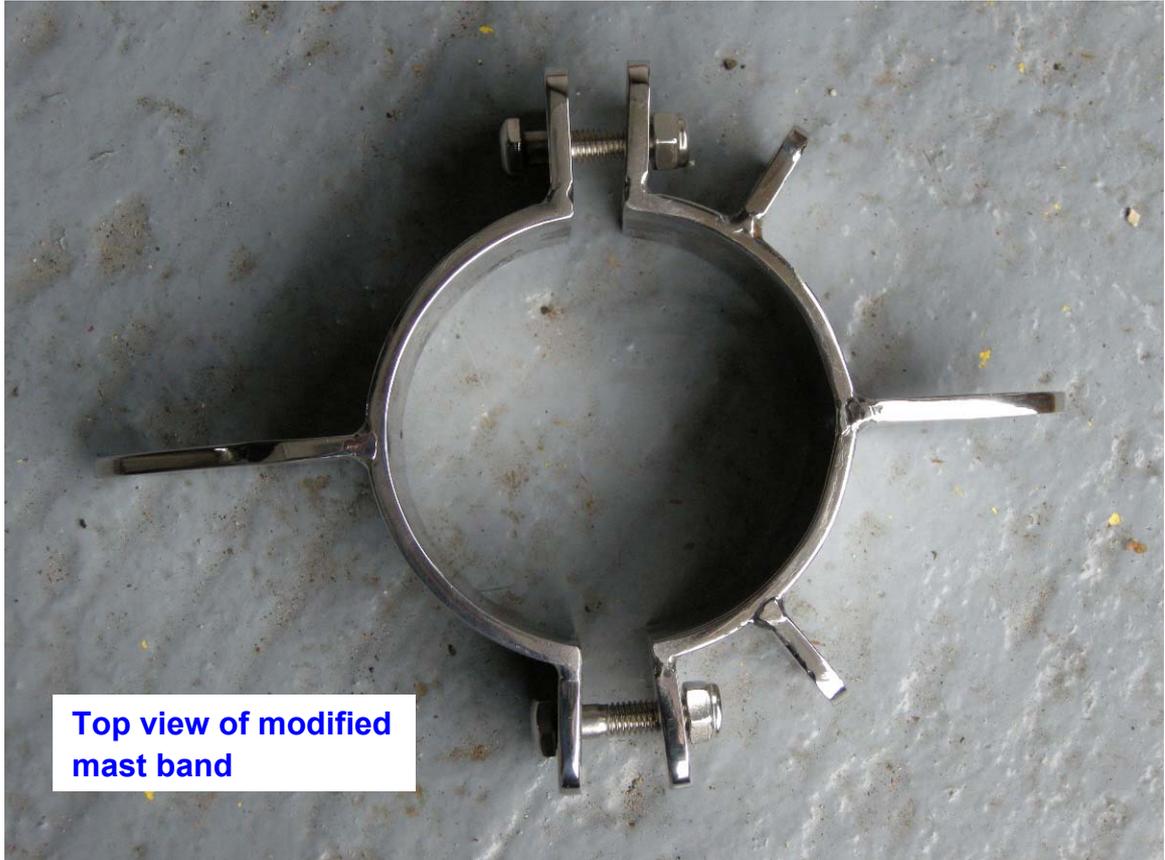
**Top view of modified mast band**

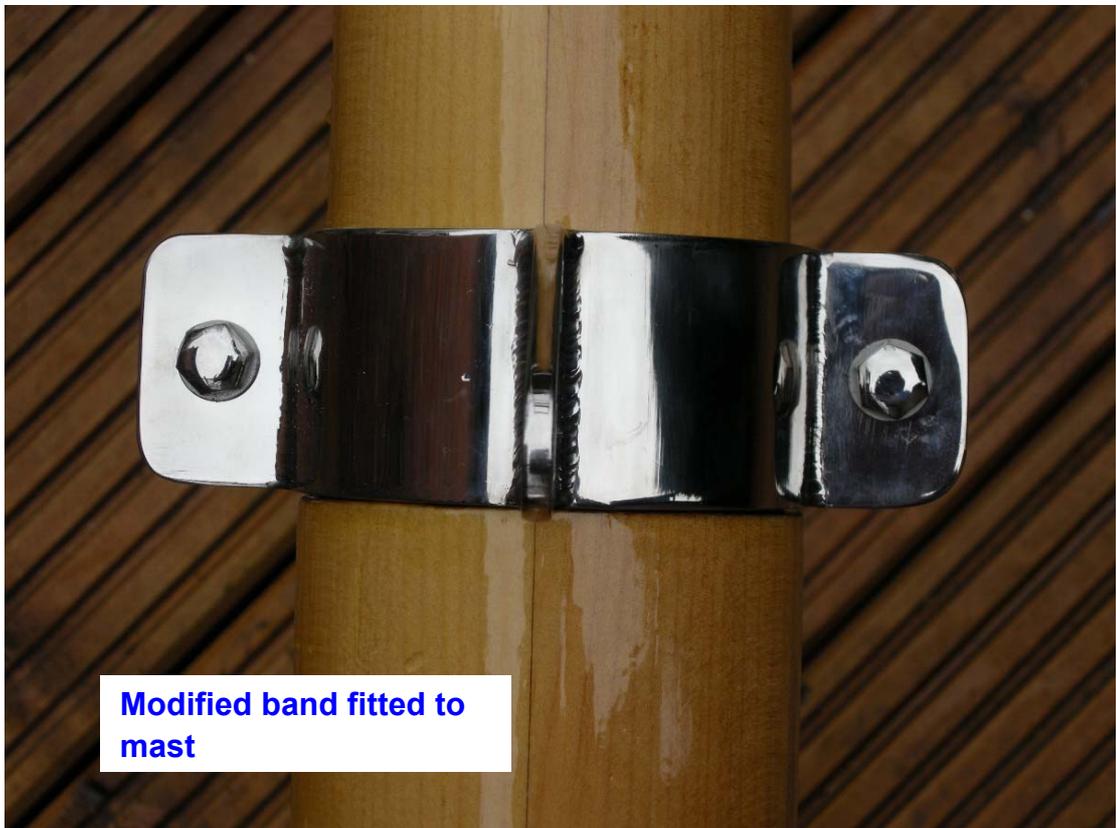
**Modified band fitted to mast**

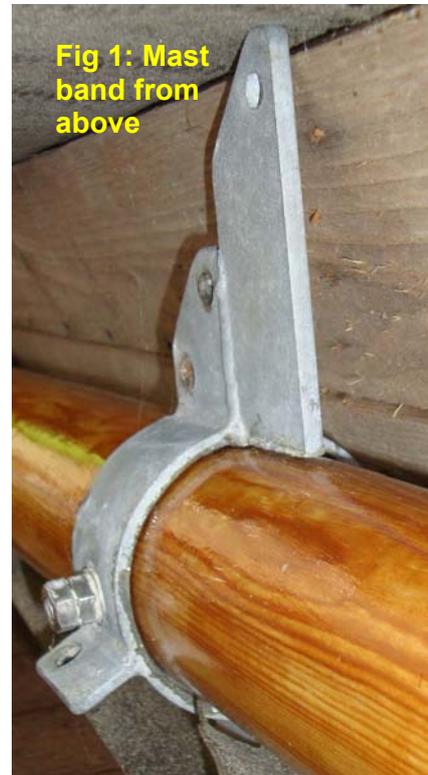
Rod's experiences are by no means unique. The design of the band and its method of attachment inevitably result in a gap around the mast, particularly at the upper edge (See fig. 1), so water will always find its way in.

The area most likely to be affected is where the securing bolt passes through the mast. Both bolt and band must be allowed some clearance so that they can be fitted and removed easily and whilst the exterior of the mast under the band is usually varnished or sealed from new, this protection rarely extends into the bolt hole. Any water entering around the bolt is therefore able to penetrate the timber, with obvious consequences.

As Rod has demonstrated, one very effective way of resolving the problem is to remove the bolt and plug the hole, but this obviously requires a modification to the band. If the standard arrangement is to be retained then ideally the surface of the hole within the mast should be sealed and this can be achieved in a number of ways.

Most effective would be to over-bore the hole and glue in a sleeve, but the danger here is that enlarging the hole on a Shrimper mast risks breaking through into the internal cable duct, which could create its own problems. Almost as effective would be to seal the internal surface of the bolt hole using a resin, water-resistant glue or similar. The seal can be applied using a short length of dowel, small enough to pass along the hole, around which a rag has been wound and tied (a piece of old towelling is ideal). Apply the seal from both sides to make sure there is a good coating over the whole length. The job is rather messy and it can be difficult to see whether the whole surface has been well coated, but even coating the outer few centimetres is better than nothing as this will help keep water out of the most critical areas. Once the resin or glue has hardened check that the bolt will still pass through. It is more than likely that the hole will need to be cleaned out, particularly if using resin, so if the bolt was originally a tight fit it might be sensible to enlarge the hole slightly before starting to avoid the chance of undoing all your good work during the clean-up process.
