## Re-Engineering a Shrimper Mast Collar

By Rod Young, Shrimper 619 (*Topaz*), (August 2010)

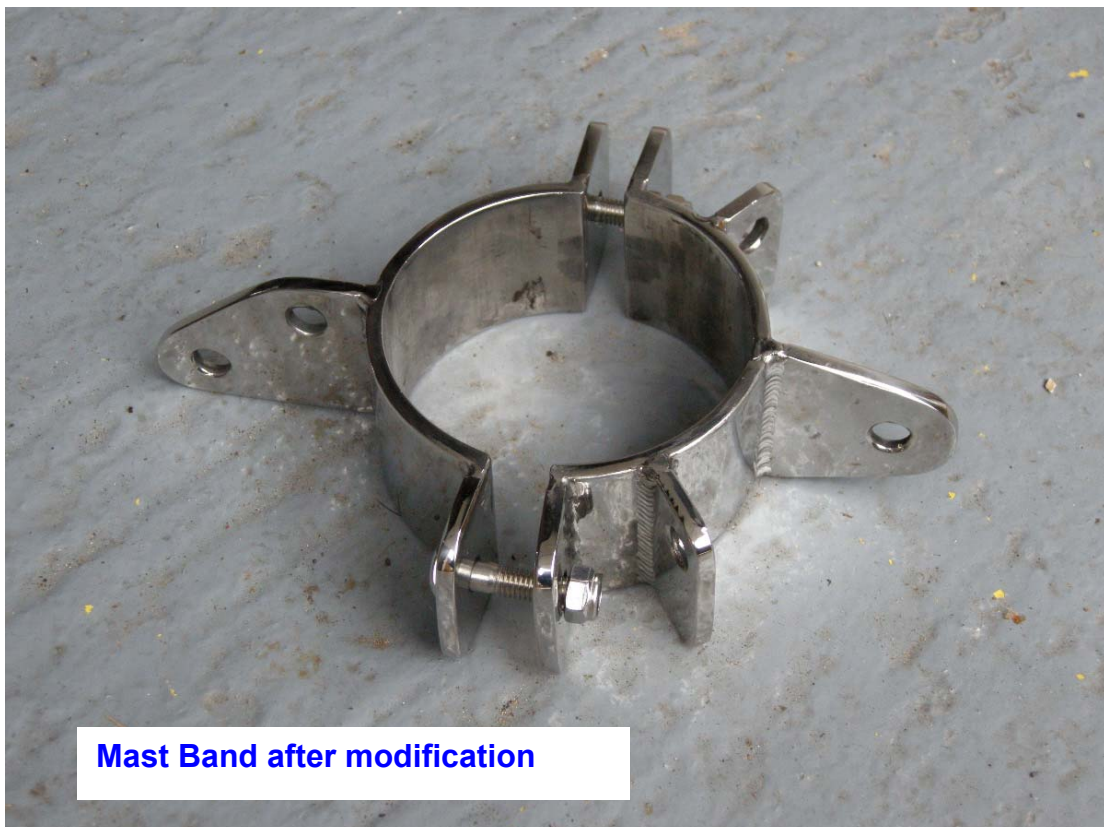
**Mast Band after modification**

Nick was familiar with the problem, and explained that, because the mast collar was secured to the mast with a stainless steel through-bolt, water could penetrate around the bolt. Unless the hole through the mast was unusually well protected when new, the eventual outcome was inevitable. His advice was to re-engineer the collar to do away with the need for a bolt. The existing collar should be cut through on each side of the bolt-holes, and flanges welded on to the four cut edges. The flanges could then be drilled for stainless steel bolts, and, instead of bolting through the mast, the collar could be clamped on.

A local steel fabricator took on the job, at a cost of around £60. As the photos show, the result looked good, and the collar clamped neatly into place. It has not budged so far, and I need not worry about my smart new mast rotting as the old one did. I recommend the solution to other Shrimper owners, preferably before rot sets in and an expensive new mast becomes necessary.

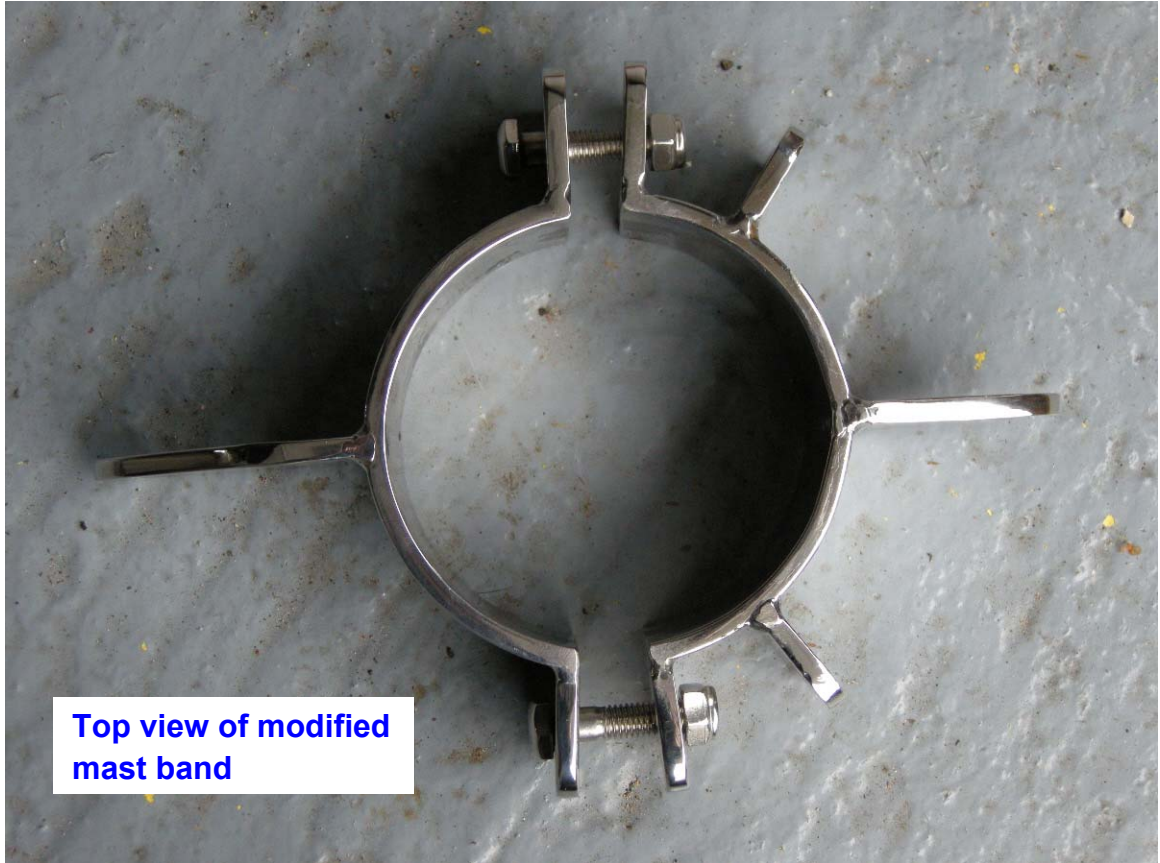
**Top view of modified mast band**

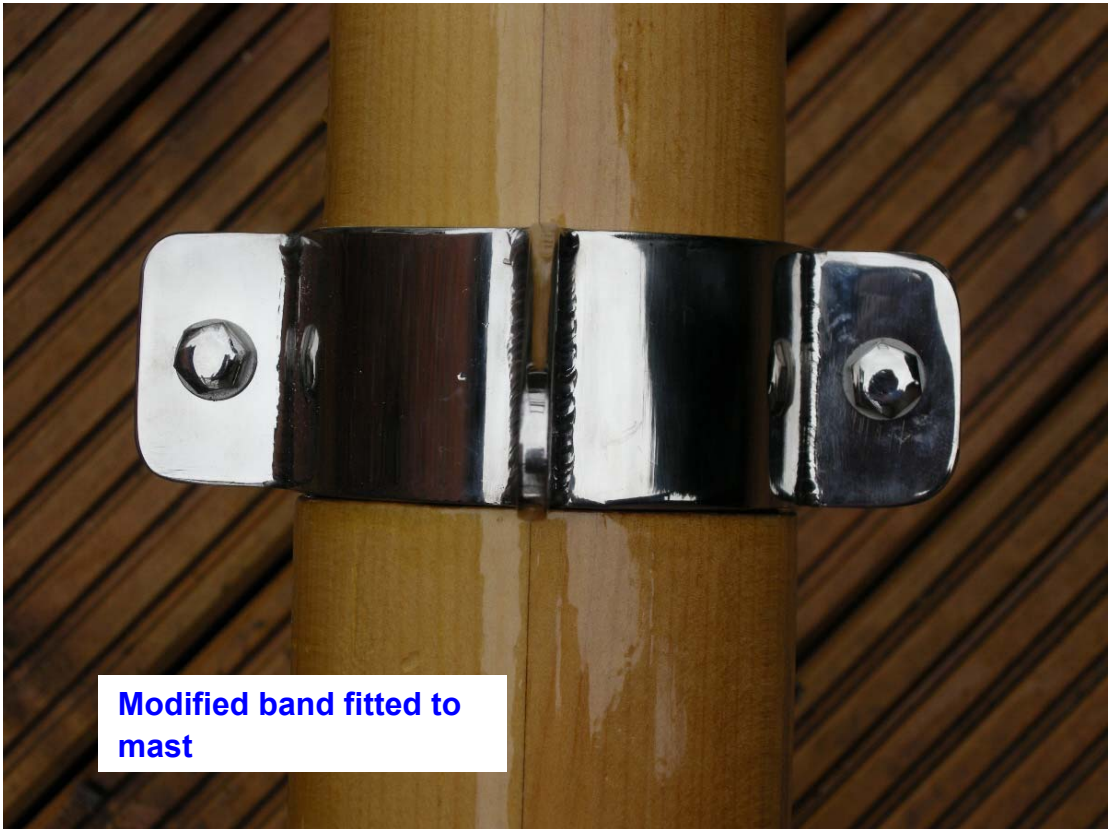
**Modified band fitted to mast**

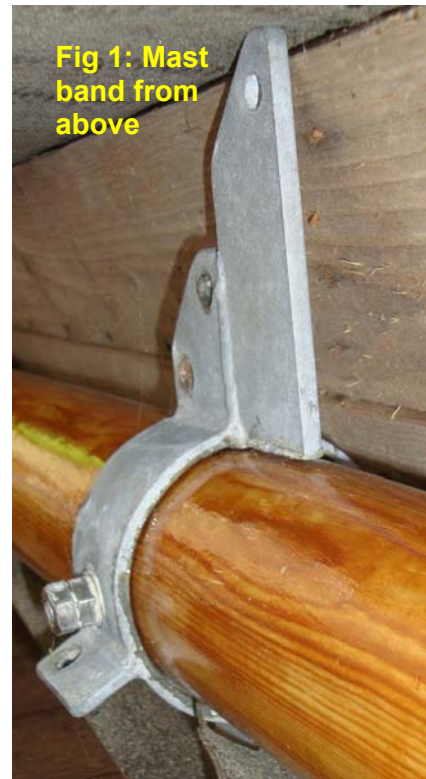
Rod's experiences are by no means unique. The design of the band and its method of attachment inevitably result in a gap around the mast, particularly at the upper edge (See fig. 1), so water will always find its way in.

The area most likely to be affected is where the securing bolt passes through the mast. Both bolt and band must be allowed some clearance so that they can be fitted and removed easily and whilst the exterior of the mast under the band is usually varnished or sealed from new, this protection rarely extends into the bolt hole. Any water entering around the bolt is therefore able to penetrate the timber, with obvious consequences.

As Rod has demonstrated, one very effective way of resolving the problem is to remove the bolt and plug the hole, but this obviously requires a modification to the band. If the standard arrangement is to be retained then ideally the surface of the hole within the mast should be sealed and this can be achieved in a number of ways.

Most effective would be to over-bore the hole and glue in a sleeve, but the danger here is that enlarging the hole on a Shrimper mast risks breaking through into the internal cable duct, which could create its own problems. Almost as effective would be to seal the internal surface of the bolt hole using a resin, water-resistant glue or similar. The seal can be applied using a short length of dowel, small enough to pass along the hole, around which a rag has been wound and tied (a piece of old towelling is ideal). Apply the seal from both sides to make sure there is a good coating over the whole length. The job is rather messy and it can be difficult to see whether the whole surface has been well coated, but even coating the outer few centimetres is better than nothing as this will help keep water out of the most critical areas. Once the resin or glue has hardened check that the bolt will still pass through. It is more than likely that the hole will need to be cleaned out, particularly if using resin, so if the bolt was originally a tight fit it might be sensible to enlarge the hole slightly before starting to avoid the chance of undoing all your good work during the clean-up process.
