The Inside View

By Graeme Bowles, Shrimper 268 (2006)

And If It Breaks Before You Check It..

By Simon Sugrue, Shrimper 355

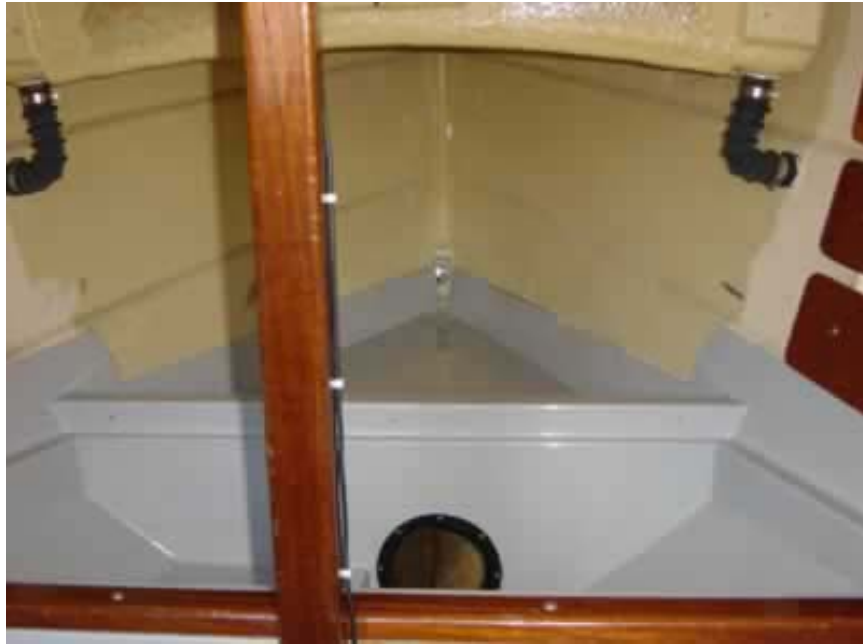
With the buoyancy removed, the bow area and eye backing pad were revealed in all their glory. My eye was in perfect condition after about 15 years in service with no signs of cracking or leakage. The backing pad could perhaps be bigger but it is obviously satisfactory as is. So, best left well alone but I always feel that it is good to get to know your boat thoroughly. I will certainly be more confident hauling out on the trailer or lying on moorings knowing what's there.
