Bow Eyes

The Inside View

By Graeme Bowles, Shrimper 268 (2006)

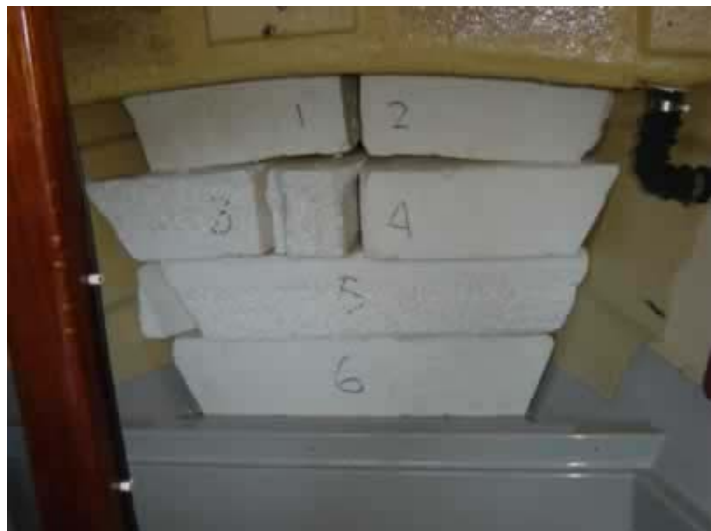
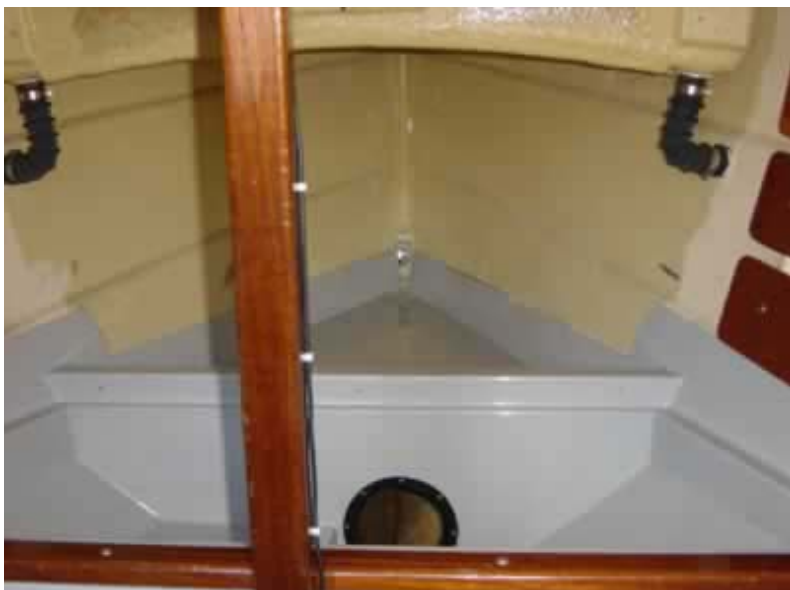
With the buoyancy removed, the bow area and eye backing pad were revealed in all their glory. My eye was in perfect condition after about 15 years in service with no signs of cracking or leakage. The backing pad could perhaps be bigger but it is obviously satisfactory as is. So, best left well alone but I always feel that it is good to get to know your boat thoroughly. I will certainly be more confident hauling out on the trailer or lying on moorings knowing what's there.

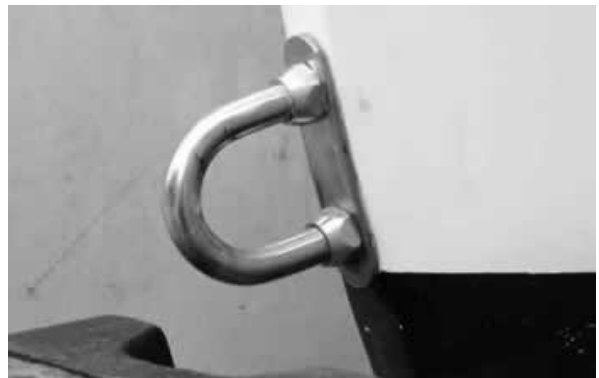
Bow-eyes have been known to break; mine did some years ago, damaging the surrounding gelcoat, and leaving *Vagabond* moored only by the insubstantial back-up rope from the samson post. Fortunately this happened just the day before I was due to pull out for the winter, so replacement and repair could be carried out ashore. My subsequent inexpert annual bodging kept the gelcoat repair looking reasonable, but by no means pristine.

Last winter, close examination (on the advice of John Benge, No 433) revealed serious cracking of the gelcoat repair, and transverse cracks in the bow-eye itself. Positive action was called for! Being something of a technophobe, and a coward to-boot, the prospect of digging out the damaged fibreglass - by now quite a large area - effecting a "proper" repair, and fitting a new bow-eye, did not immediately appeal to me. That's when John, who is neither technophobe nor coward, took the situation in hand, assuring me it was not a problem.

"Just don't look while I'm doing the angle-grinding," he said. I didn't. "Trust me -I'm a doctor" he said. I did - just! While I made the coffee, he carved out a sizeable chunk of fibreglass. Refilling the hole, and profiling the gelcoat, I found positively therapeutic - John even allowed me to do some final smoothing off with ultra fine gauge wet and dry. Holes for the bow-eye u-bolt were then drilled, from the inside and VERY carefully.

Now for the point of this article - the design mod. By fitting the new bow-eye plate, suitably angle-ground to fit the shape of the stem, on the outside, the gelcoat is protected both from the pressure of tightening the nuts, and also from any lateral pressures imposed by the mooring chain. The old plate is used inside, as before.
