Changing the Oil Pipes on an Inboard Shrimper

By Jonathan Davies, Shrimper 19 *Merriwinds* (847) – July 2023

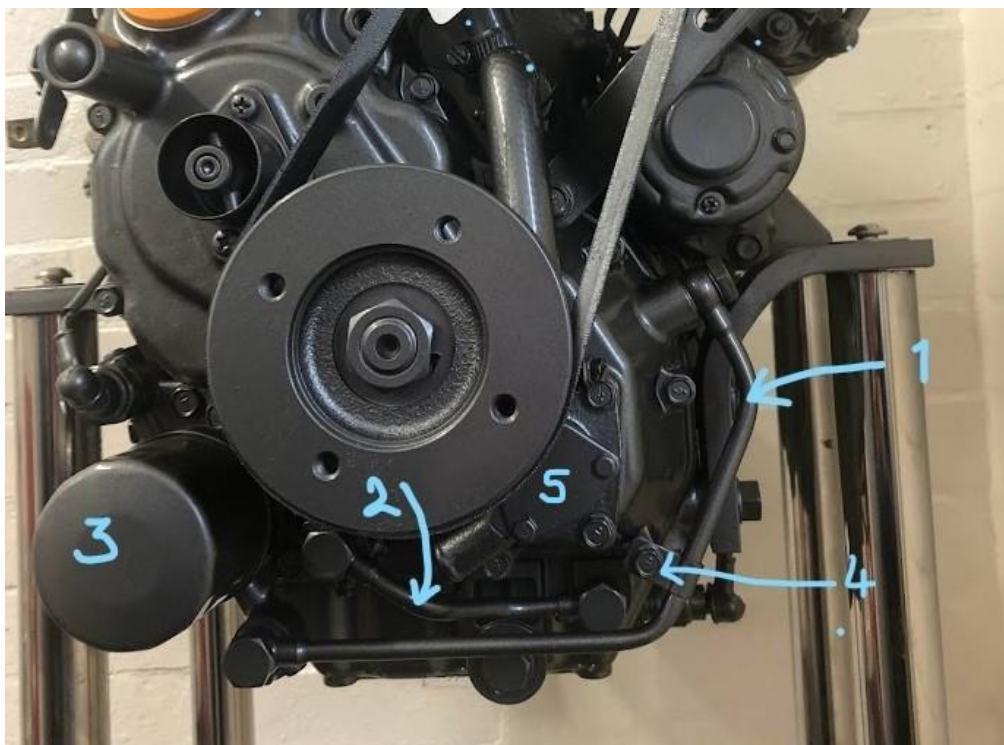
The Yanmar 1 GM10 has a well-known 'weak point' if it is not maintained correctly. The external oil pipes pass close beneath the water pump, which, if it leaks (even just an occasional drip) can allow sea water to run over the painted mild steel pipes, leading to rust. Eventually the corrosion can lead to a pipe failing, engine oil escaping into the bilge and the low oil pressure buzzer sounding to let you know you are in trouble. The motor then must be immediately stopped before it gets seriously damaged. This scenario is not uncommon in older boats.

The above photo shows the positions of the various components:

1. Long oil pipe, directly beneath the water pump and the most likely to corrode
2. The short pipe, set slightly further back.
3. The oil filter.
4. The supporting bracket and bolt.
5. The water pump. (This view is also useful to see the position of two of the three small cover bolts, one is hidden behind the pulley, if you are intending to renew the impeller).
6. (Shown on next photo) is the sump drain plug, larger than 19mm it shouldn't be confused with the other bolts.

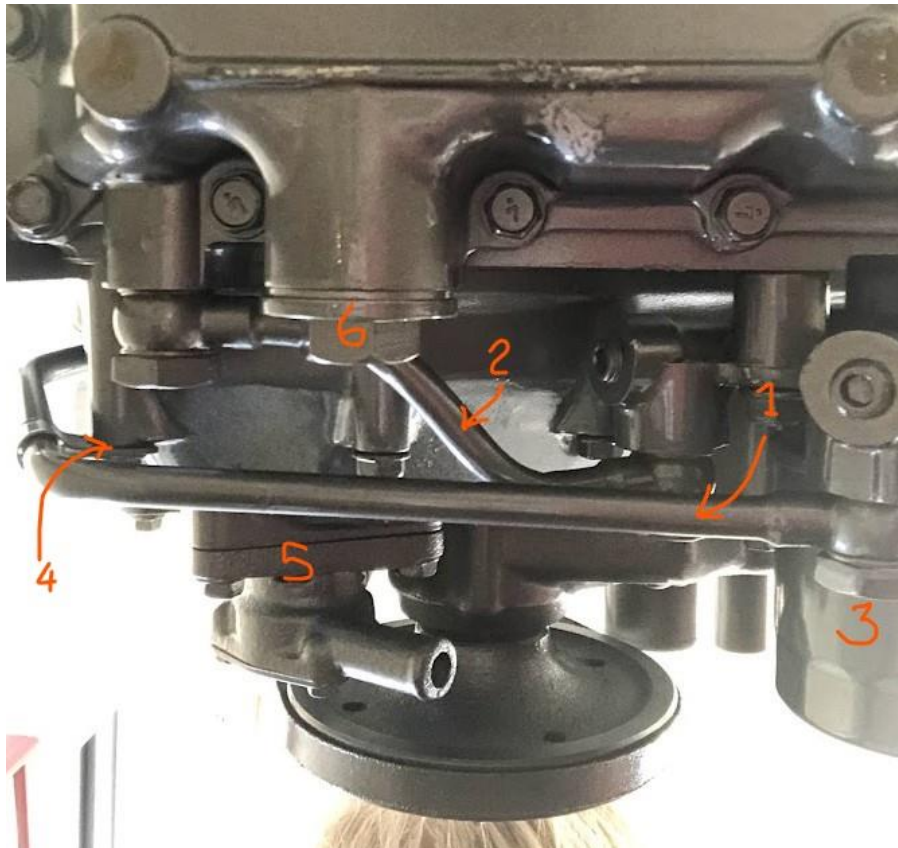
The view from underneath.

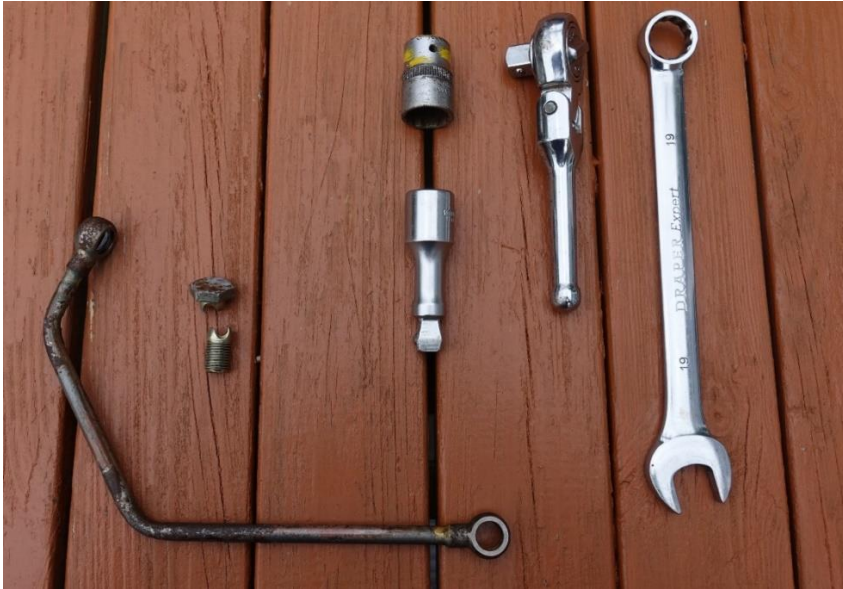
The photo shows the removed long pipe together with the tools I mainly used. At first sight it did not look too bad and I wondered if it was necessary to replace it yet. However, once cleaned back to bare metal with a wire brush, some quite deep pitting became more evident on the whole surface. The pipe could not be trusted for very much longer. In the eight years of my ownership the water pump has never been left to leak; perhaps the rust is just the result of 20 years exposure to sea air. The pipe has now been replaced with one made from stainless steel.

I obtained the stainless-steel replacement long pipe with washers from E bay for £99. The little supporting bracket was folded around it and I was relieved to see that it all fitted perfectly.
