Centreboard case distortion in Cornish Shrimper No. 124

Robin Whittle

No 124: Bumble Chugger (BC) was built in 1983.

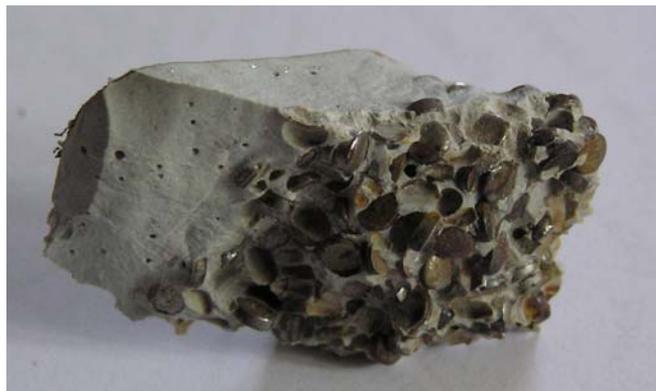
I discovered from discussion with Cornish Crabbers Ltd (now Select Yachts) that the ballast is made up of steel pressings set in a compound of slate dust and polyester resin. In BC each pressing is about 3 mm diameter and 1 mm thick. Several million of these pressings are used to make up the volume of ballast

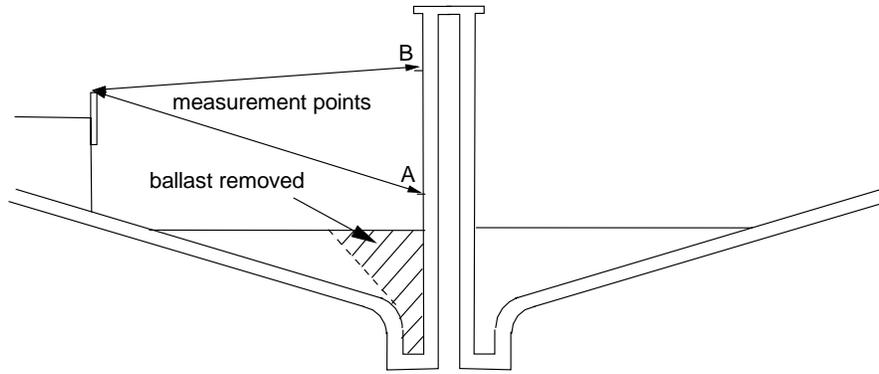
Figure 1: Section through hull showing the ballast removed

During the summer the centre board remained free to move up and down until mid-August, when it started to stick again. This suggested that the bulge had increased during this time. I decided to replace a strip of ballast 4 inches wide adjacent to the starboard side of the case (see Figure 1). Before I started work I checked the position of the centreboard case by taking measurements from the top of the bunk lath to a series of eight points at two levels 'A' and 'B'.

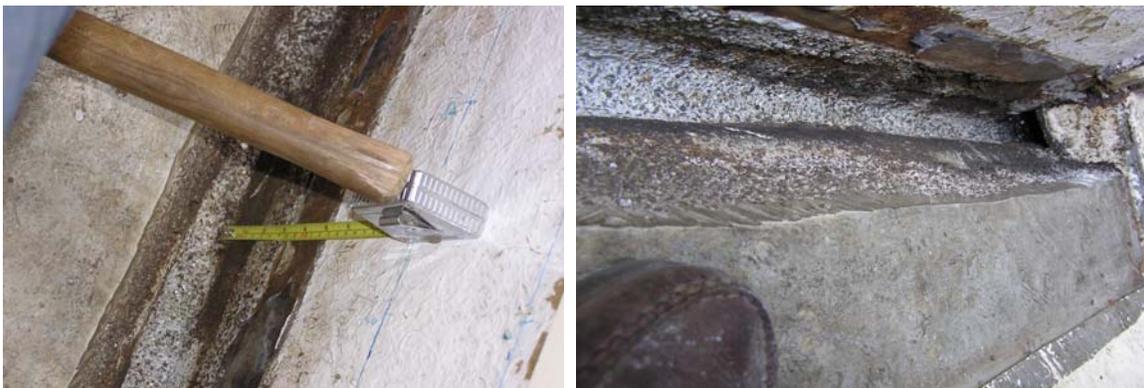
Contrary to my first expectations the rusting had not spread from the rear end of the centreboard case. Although the plywood bulkhead at that end had been distorted by the expansion of the ballast, the steel pressings close to the centreboard case were not rusty. Rusty areas close to the centreboard case appeared to be randomly placed, possibly related to how dense the ballast mix had been.
