## *Centreboard case distortion in Cornish Shrimper No. 124*

*Robin Whittle*

No 124: Bumble Chugger (BC) was built in 1983.

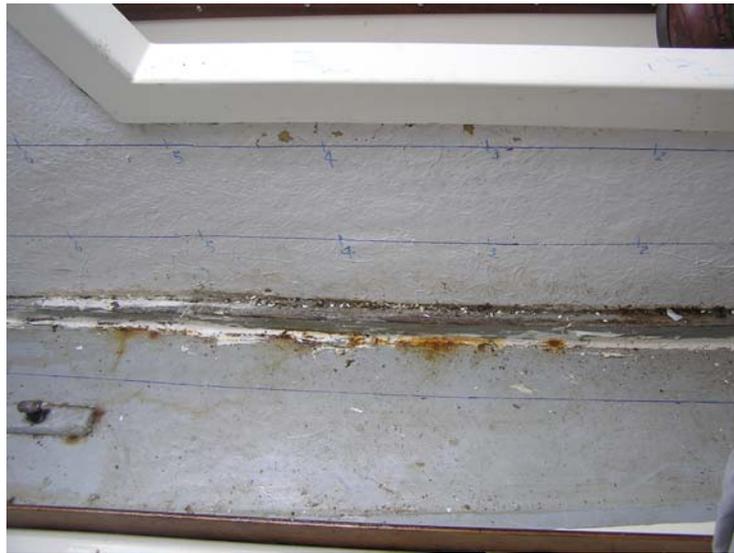
After some thought during the winter months when BC was laid up I considered the possibility that the centreboard case was being squeezed by the ballast. I removed the floorboards to examine the ballast for any signs of movement. A crack had opened up along the starboard side of the centreboard case. It varied from 2 to 4 mm wide and had caused the strip of wood which supports the floorboard to separate from the centreboard case over a length of about 500 mm.

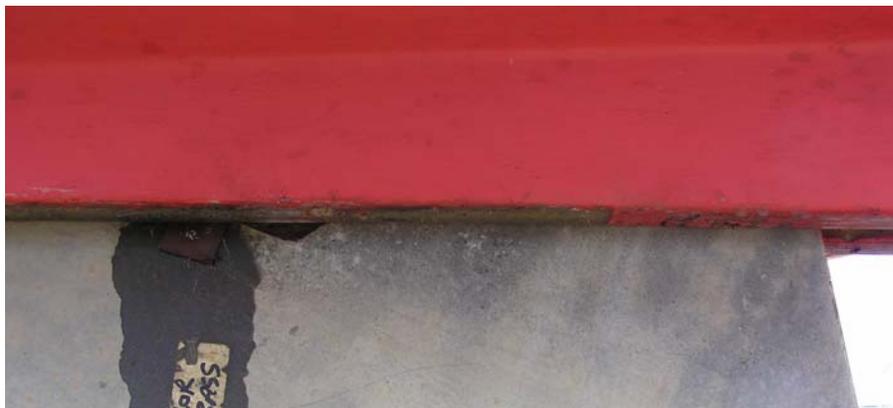
During this operation the centreboard was moved sufficiently to allow a visual check inside the centreboard case. A bulge could be seen on the starboard side.

BC was placed on the cradle at the Felixstowe Ferry Boatyard again at Easter, 2004 (9/10 April) and the centre board was lowered to remove the tuffnel blocks. At the same time I tried to remove the centreboard altogether. This was not possible. At the hinge point a collar passes through the centreboard and projects out each side by 2 mm (approx.). It was this collar that jammed on the centreboard case and prevented it from being removed. I replaced the centreboard to its inboard position and confirmed that it was free to be raised and lowered without jamming.

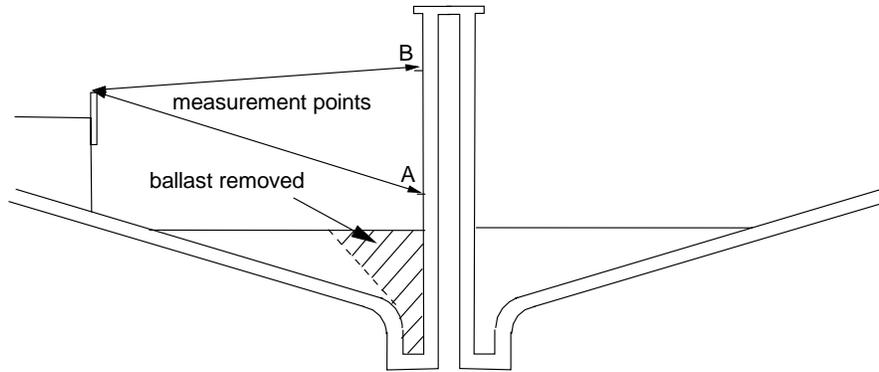
**Figure 1: Section through hull showing the ballast removed**

During the summer the centre board remained free to move up and down until mid-August, when it started to stick again. This suggested that the bulge had increased during this time. I decided to replace a strip of ballast 4 inches wide adjacent to the starboard side of the case (see Figure 1). Before I started work I checked the position of the centreboard case by taking measurements from the top of the bunk lath to a series of eight points at two levels 'A' and 'B'.

At the beginning of October, 2004, I began the work. The tools included an 'angle grinder' with a 200mm metal cutting blade, a sledge hammer and cold chisels. Paper overalls, goggles and breathing mask were essential as the angle grinder created a great deal of dust and flying pellets. It was a horrid job.

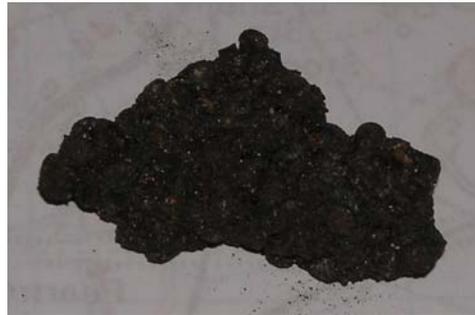
Close to the centreboard case there were patches where the steel pressings had rusted and formed a clinker.

This clinker had formed expanding struts which had caused the centreboard case to be squeezed. In one place there was a void in the ballast about 50 mm long, 20 mm wide and high but the steel pressings around its surface had surprisingly not rusted.

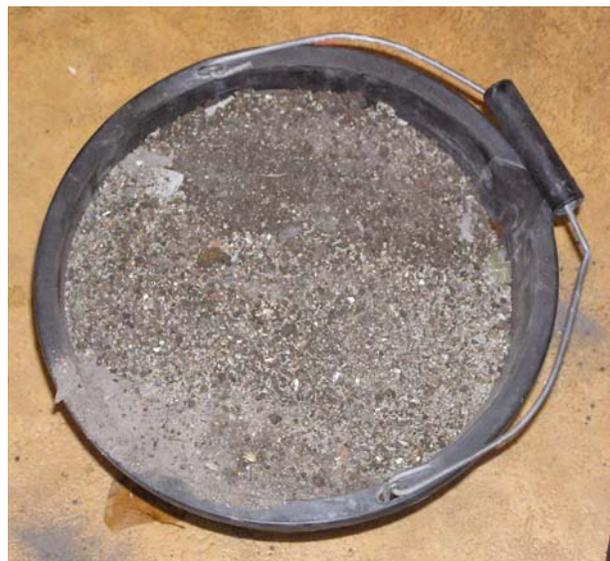
In total I removed 6 stone (38 kg) of ballast. The volume of this filled a plastic bucket.

I replaced the ballast with 4½ stone (29 kg) of lead. This was melted down and poured over a paving stone to produce thin flat sheets. I have to admit an appalling accident during this operation. I had been using a specially bought saucepan for melting the lead which was done by heating it up on our gas cooker! A particularly large piece of lead was precariously balanced in the saucepan and slowly melting from the bottom up. I took my attention off it, for just a moment, and of course disaster occurred. The lead had slowly tipped over as it melted and the saucepan lost its balance!! The whole lot, including a considerable amount of molten lead then fell over towards me. I was just quick enough to jump out of the way to avoid being burnt - but the vinyl floor wasn't so nimble!!! Gillie was not best pleased. The outcome was that I had to lay a new kitchen floor.
