Check That Stern Gland!

By Graham Turner, Shrimper 438 (Julie Kate) (Autumn 2007)

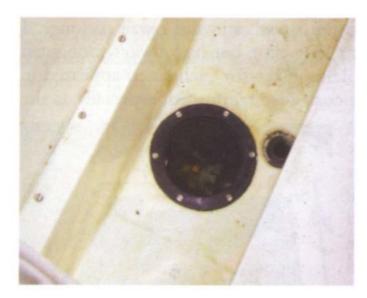
This is the view of the stern gland you normally get through the access hatch - not a lot to see!

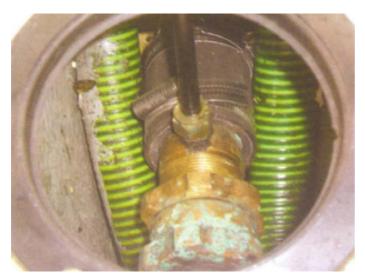
This close up shot shows the new rubber hose nicely, picked up by the camera flash. It's not normally this easy to see, but the bilge pump hoses prevent a thorough examination.

If you need to replace it, the prop shaft will need to be withdrawn, so while you are at it you might as well replace the cutless bearing and repack the stern gland. Don't forget to check the engine mounts at the same time.

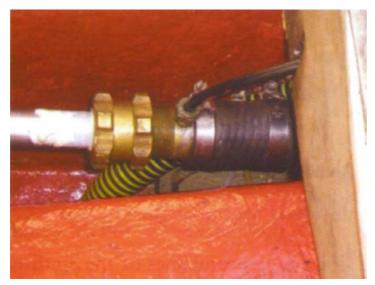
That's better! A view of the assembly with the cockpit floor removed.
