## **Pivot Bolts On Rudders & Centreplates**

By Mike Broad, Shrimper 500 (*Damzelfly*), (Spring 2003)

## More on bolts!

By Mike Broad, Shrimper 500 (*Damzelfly*) (Winter 2004)

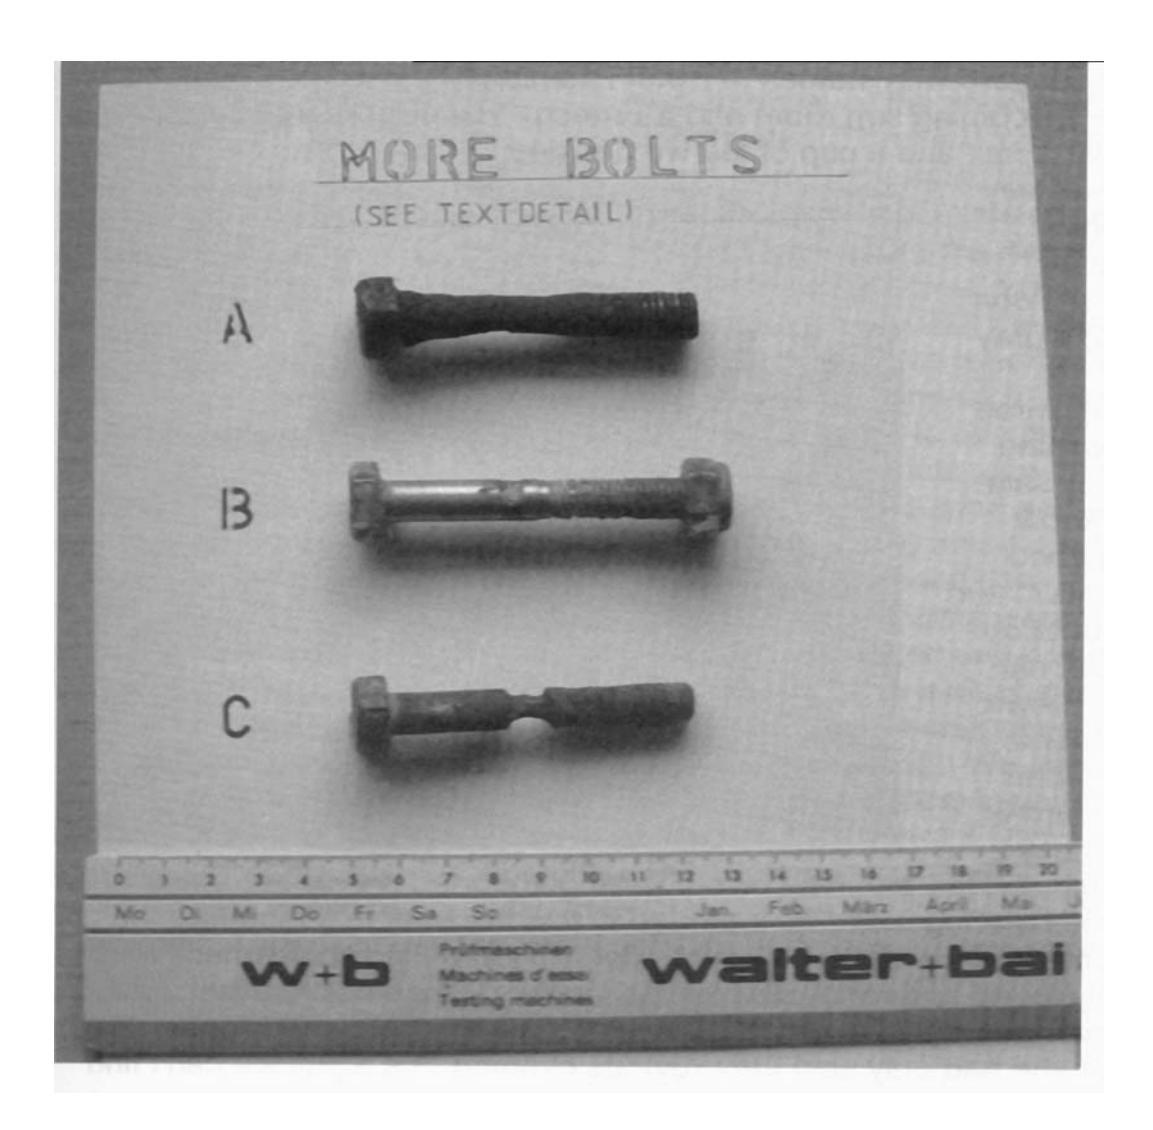
I was surprised that reader Paul Rich (Winter 2003 magazine) was disappointed to find that his boat's centreplate pivot bolt was still in good condition. Fortunately this is the "norm". Of the boats we checked locally, all but one was also in pristine condition. The rare exception is shown in the attached photo, marked (A). Nuff said.

Photo (B) shows an M10 stainless steel rudder pivot bolt. Interestingly, there is evidence of pitting on the diameter, due to the well-documented phenomenon of anaerobic corrosion of some stainless steels. Nothing to worry Shrimper owners, even in our "ultra saline" waters...!

Photo (C) shows a badly worn M10 galvanised steel rudder pivot bolt from an older Shrimper (before stainless steel fittings became standard). The deep wear groove is very clear - fortunately the owner discovered the problem whilst ashore. Replacement of the old galvanised steel rudder plates, bolts, hangings etc., with the later stainless variety seems to cure the problem. Although our Shrimpers are very sturdily constructed, moving items will not last forever, so regular maintenance should be a key part of boat ownership.
