# Outboard Engine Hinged Bracket

Robin Whittle

# Outboard Engine Hinged Bracket Modifications to Transom Block

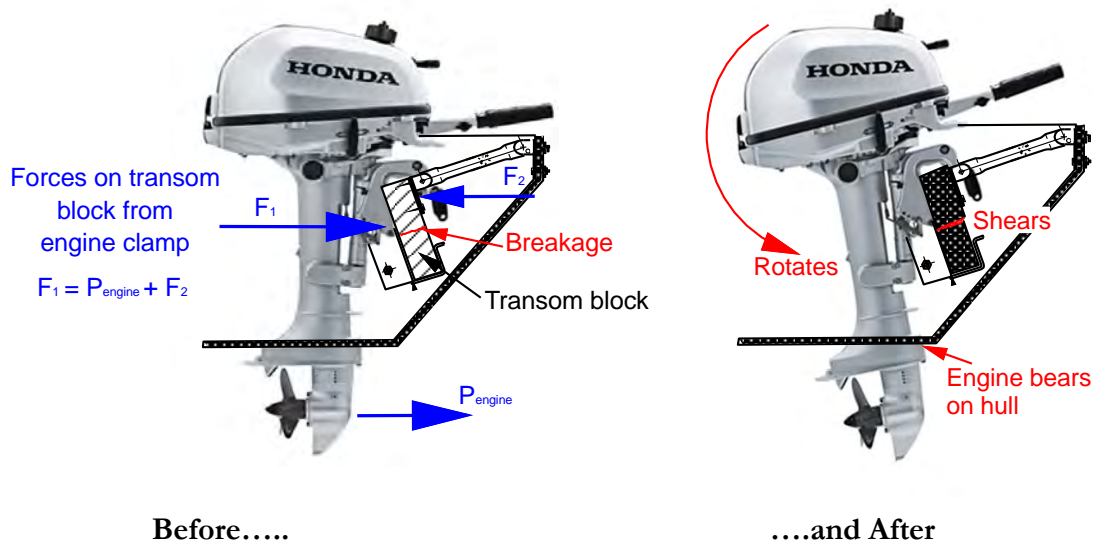
Figure 1: Split in transom block

My outboard engine bracket appeared to be working well throughout the 2022 season. It was only when I raised the engine for the last time that I found that the transom block had split across into two parts. This allowed the engine to rotate when in the down position. Figure 1 shows what had happened.
