## Refurbishing *Winkle's* Centreplate

By Keith Thatcher, Shrimper 144 (*Winkle*), September 2012

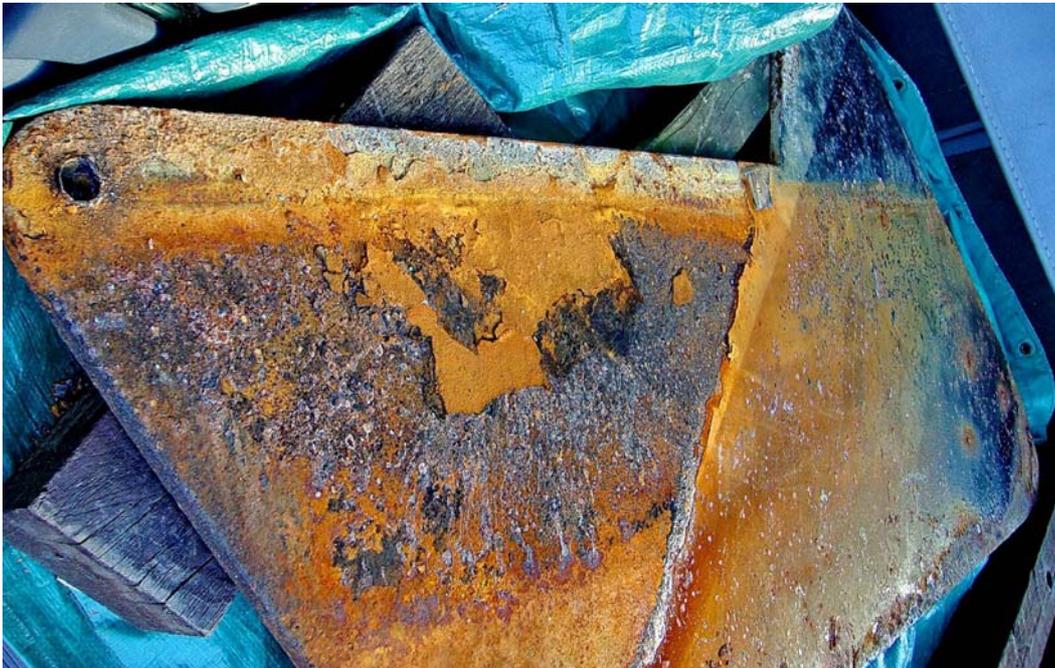
In late October *Winkle* was taken back to Poole Yacht Club where she was lifted off her trailer whilst helpers stood ready to catch and support the centreplate as it emerged. We needn't have worried - the upper part of the plate jammed at the bottom of its slot and had to be "walked" out by repeated lifting and lowering the boat in the hoist. Once free, we finally saw the full extent of the deterioration - not pretty sight (see fig 1).

**Fig 1: Centreplate as removed**

I opted to have the centreplate re-galvanised – other owners have used alternative coatings, such as epoxy paint (see Chris Sharland's account of *Shellback's* plate repair in this section). Whatever the coating chosen, it essential to remove all rust and old paint before applying, which is best done by shot blasting. Luckily, another Poole based owner, Roy Ratazzi, (*Folly 121*), had been down the same road a couple of years earlier and provided much useful advice and information. We are lucky in having a galvanising contractor, Wessex Galvanizers, located in Eastleigh, Hampshire, and less than an hour's drive from Poole. There is also a shot blasting contractor on the same industrial estate, which most owners seem to use, but to avoid too many trips along the M27, I chose a local firm in Poole. A full list of the suppliers used is included at the end of this article.

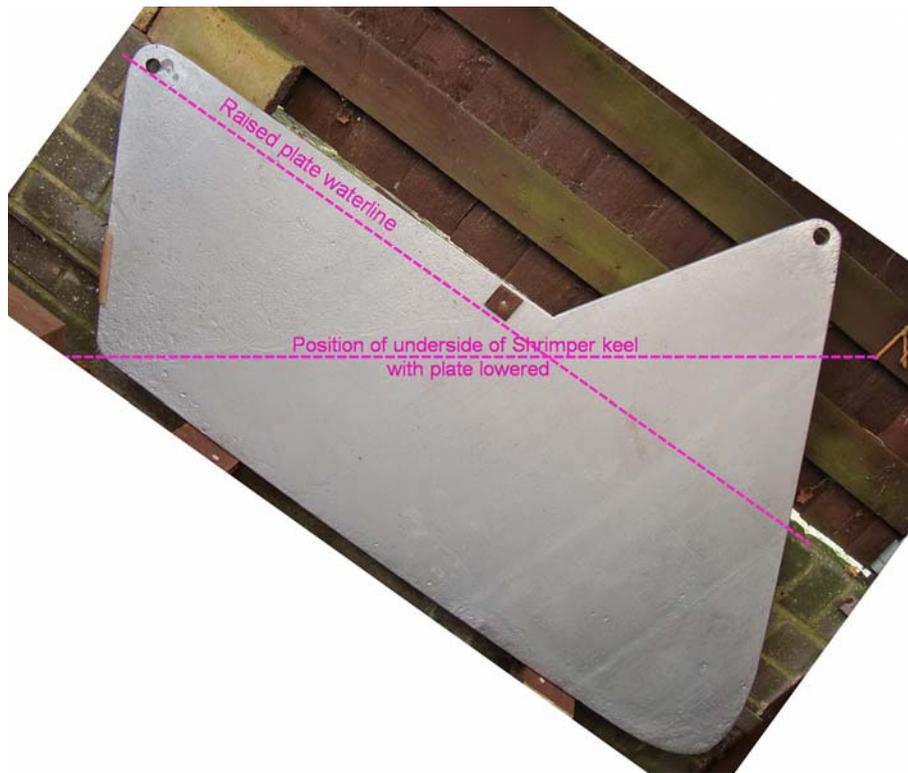
**Fig 5: Lowered plate representation**

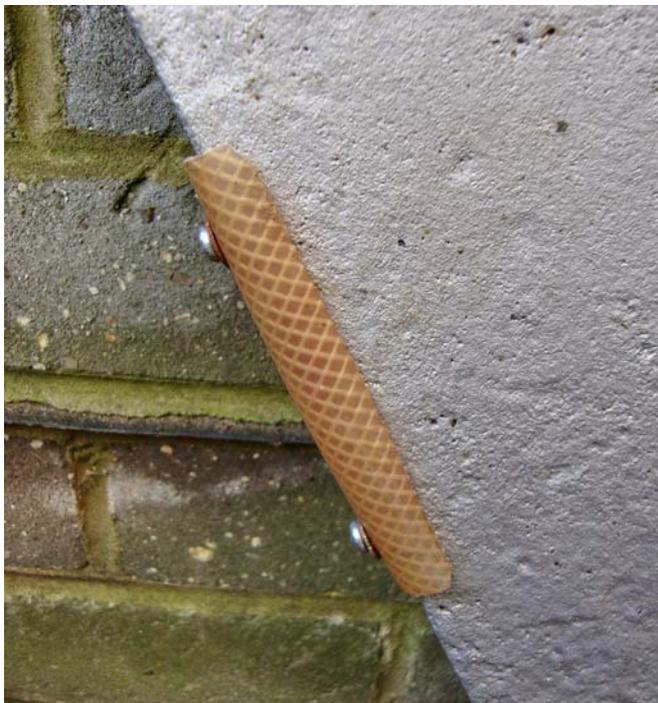
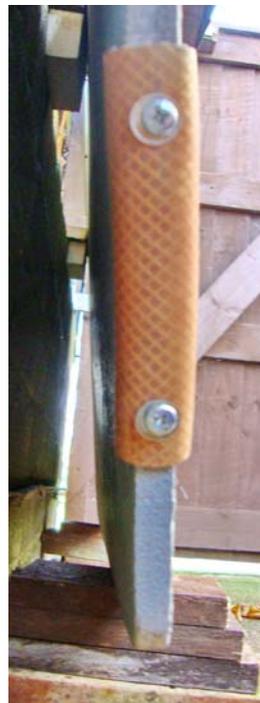
Contrary to popular belief, this is not a bumper to prevent damage to the forward end of the case should the plate be lowered too far. Just two very rusty screws and washers remained when *Winkle's* plate was removed and I subsequently discovered that these originally held a short length of plastic tube, similar to that used on the bilge pump, slit lengthways to straddle the edge of the plate. As a consequence the screw heads protrude - not a good idea for a bumper – and, as can be seen in Fig 5, which represents the plate when lowered, the buffer doesn't actually touch the end of the case, the first point of contact being the lower rounded corner of the centreplate. The conclusion, therefore, is that this buffer is intended to hold the plate central and prevent the forward end moving from side to side when lowered.

**Figs 6 & 7: - Forward edge buffer**

Having ground off the broken stubs, I drilled and tapped new M5 holes in the leading edge of the plate about 15 mm below the originals and fitted 110 mm of 1" o/d reinforced PVC hose (the length isn't critical), slit longitudinally to straddle the plate thickness. Hole depth was about 20 mm into which was fitted a 25 mm long cheese head screw with washer. This allowed the screw to bottom-out before pulling the tube hard against the plate. The cut edges were also trimmed so that the finished width of the buffer when screwed home would not exceed the width of the case slot, about 24 mm. See figs. 6 & 7.

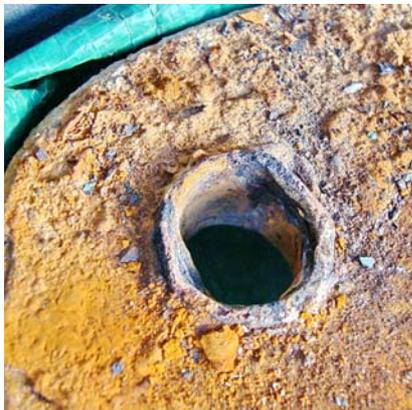
On *Winkle's* centreplate the area around the pivot bolt hole was extremely rusty (see fig 8) and although Cornish Crabbers told me that the bush should just tap out, it being a snug push fit when new, after 28 years mine was well and truly rusted in. Extraction therefore called for some brute force – a large hammer and brass drift. But first I carefully cut radial slots in the bush using a small hack saw. This allowed the steel tube to fold inwards as it was thumped, so reducing its hold and allowing removal without damaging the hole, which luckily was not worn. Cornish Crabbers supplied a new bush, now nylon, in place of the original mild steel. When fitting the new bush, after galvanising, some dressing of the bolt hole was necessary, owing to the irregularities in the coating. The bush was given a thin coating of grease to ease its entry into the plate and provide some compensation for the zinc removed whilst dressing the hole. Original and new bushes are shown in figs. 8, 9 & 10.

Fig 8: Original bush in place

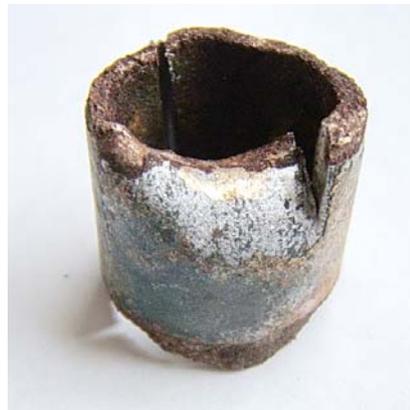
Fig 9: Bush as removed

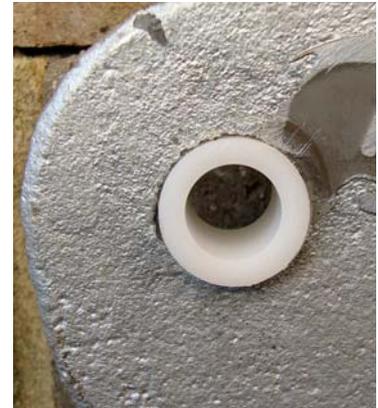
Fig 10: New bush fitted

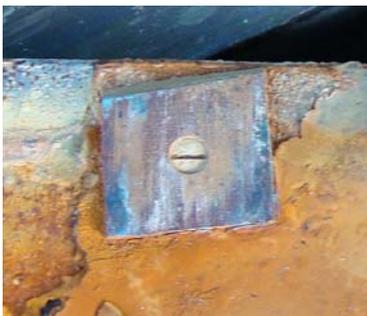
These should be two pads of Tufnol, about 40 mm square x 3 mm thick, each attached with a single countersunk M5 screw with the head below the surface of the pad so as not to damage the case. Some owners have found one or both missing. *Winkle's* were both still in place, but on one the Tufnol had dished - it was this that had caused the plate to stick as it was being removed. I replaced both pads with 3mm thick pieces cut from a 50 mm dia. bar of High Density Polyethylene (HDPE), which has excellent wear resistance and low friction. These were secured using 12 mm x M5 countersunk screws trimmed to prevent them meeting in the centre of the plate. (See figs. 11 & 12)

Fig 11: Original Tufnol pad

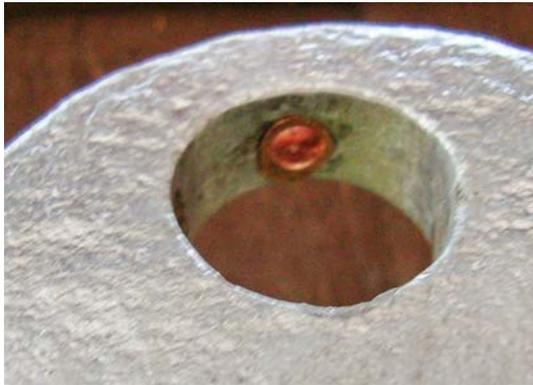
For the 2011 season Winkle had been fitted with a Dyneema line in place of a wire, but when removed in October significant fraying had occurred where the line left the plate. Once the plate had been removed I discovered significant rusting, both within the hole and around its top edge. This was cleaned out prior to shot blasting, the first step being to run a drill down the wire attachment hole. I also smoothed the exit and entry areas to create a countersink.

Fig 13: Copper tube hole liner underside

The nominal diameter of the wire hole is about 4 mm, but by the time all rust had been removed and the plate had been shot blasted back to good metal this had become 7 mm, too large for the standard Talurite ferrule. After galvanising I fitted a copper tube liner, belled at each end to hold it in place, which reduced the wire hole diameter to about 4.5 mm. I was intending to re-fit the Dyneema line, but feared that even a substantial securing knot would still lie predominantly within the area of the liner, which might then pull out. To spread the load into the surrounding plate I made up a saddle from a piece of 25 mm dia. stainless steel tube. The finished copper liner and saddle can be seen in Figs 13 to 15. Also visible in Fig 15 are 2 x two turns of 3 mm line, one tied each side of the lifting line, that act as a buffer and hold the top of the centreplate central in the case. This is common to all centreplates, both Mk1 and Mk2.

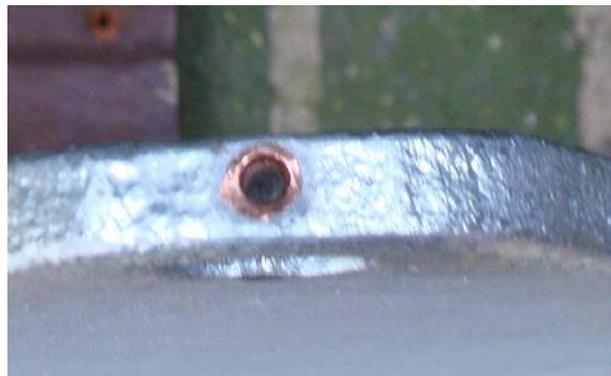
Fig 14: Copper tube hole liner top view

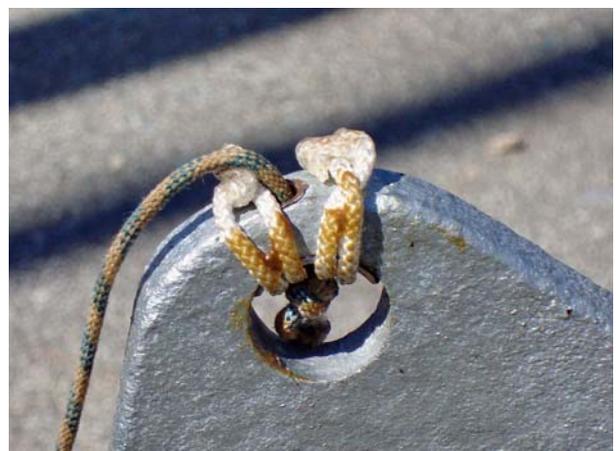
Fig 15: Support saddle in place with Dyneema lifting line & buffer lashings

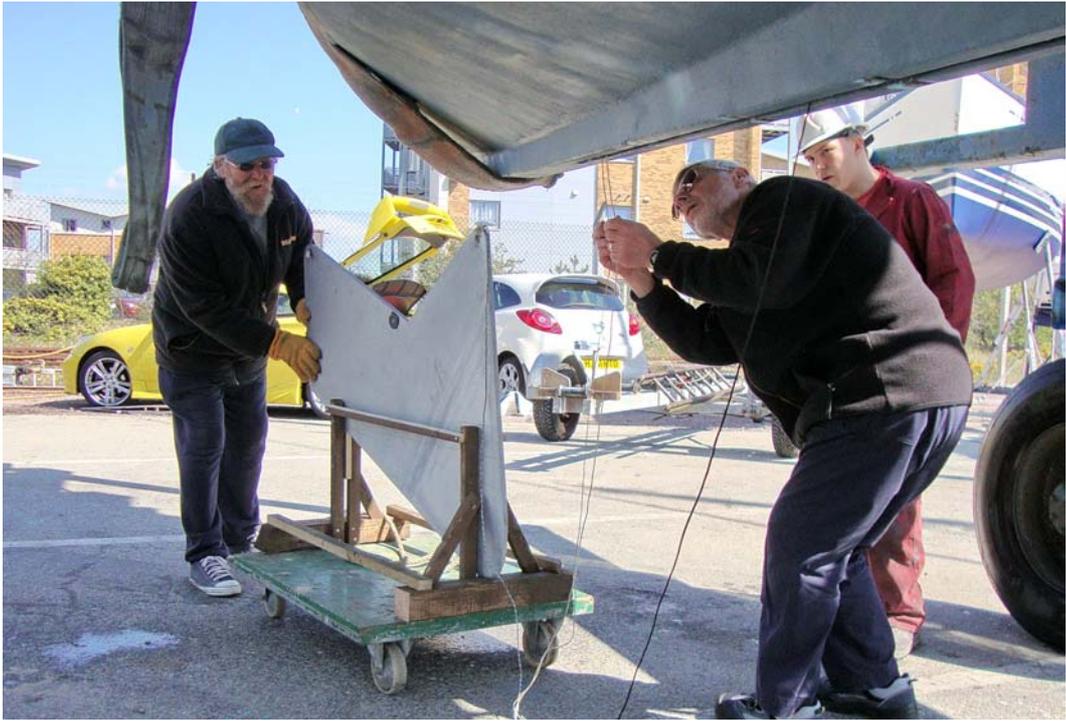
**Fig 18: Plate brought to boat & guide lines attached**

During preparation for re-fitting, two light lines, one aft, one forward, had been dropped down the case from within the boat. The aft line was attached to the free end of the plate winch rope so that it could be pulled up through the case and fed onto the winch ready to lift the centreplate into the boat. The forward line was a continuous loop running from one case bolt hole (inside the cabin), down the slot, through the bolt bush in the centreplate, then back up the slot to exit into the cabin via the other case bolt hole. It was intended as a guide to show where centreplate and case bolt holes were as the plate was slid home. Be sure to use a very thin line for this purpose – whipping twine is ideal - as clearance between the bush and case sides is very small, barely 3 mm total, and anything thicker will be cut. I speak from experience as the line we used was too thick and was neatly cut as the plate slid up the case.

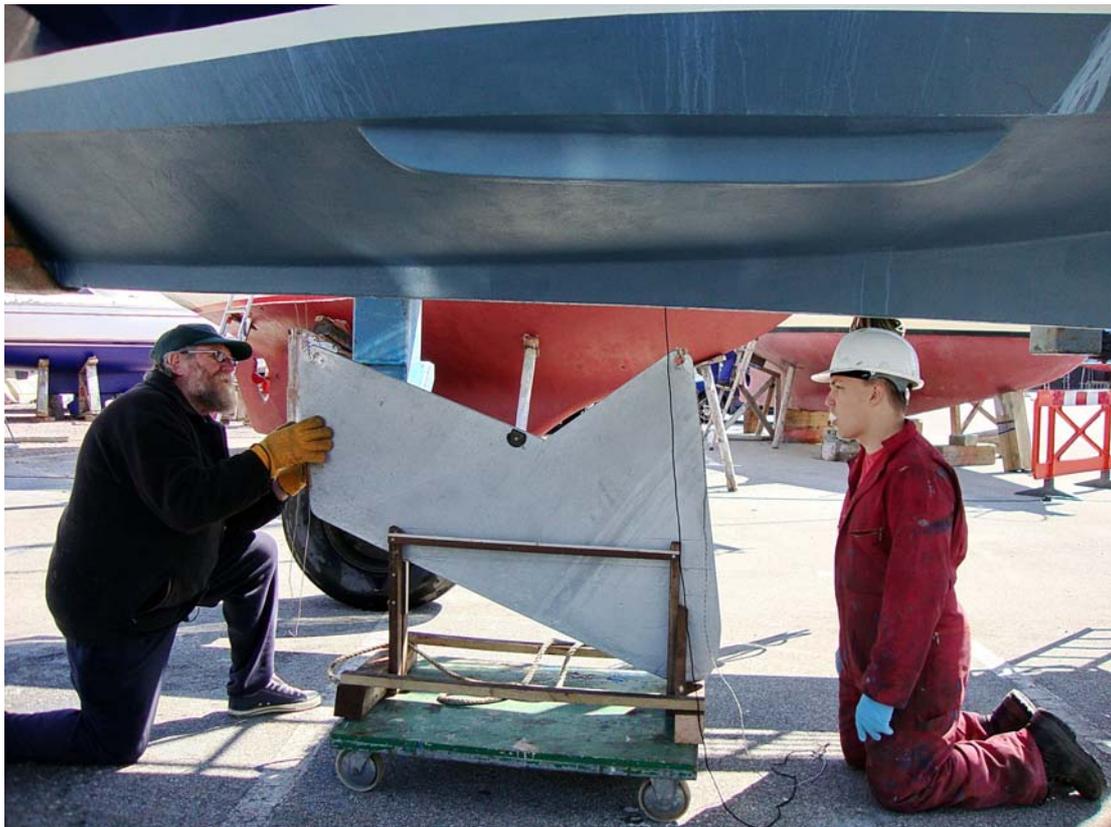
**Fig 19: Lining up**

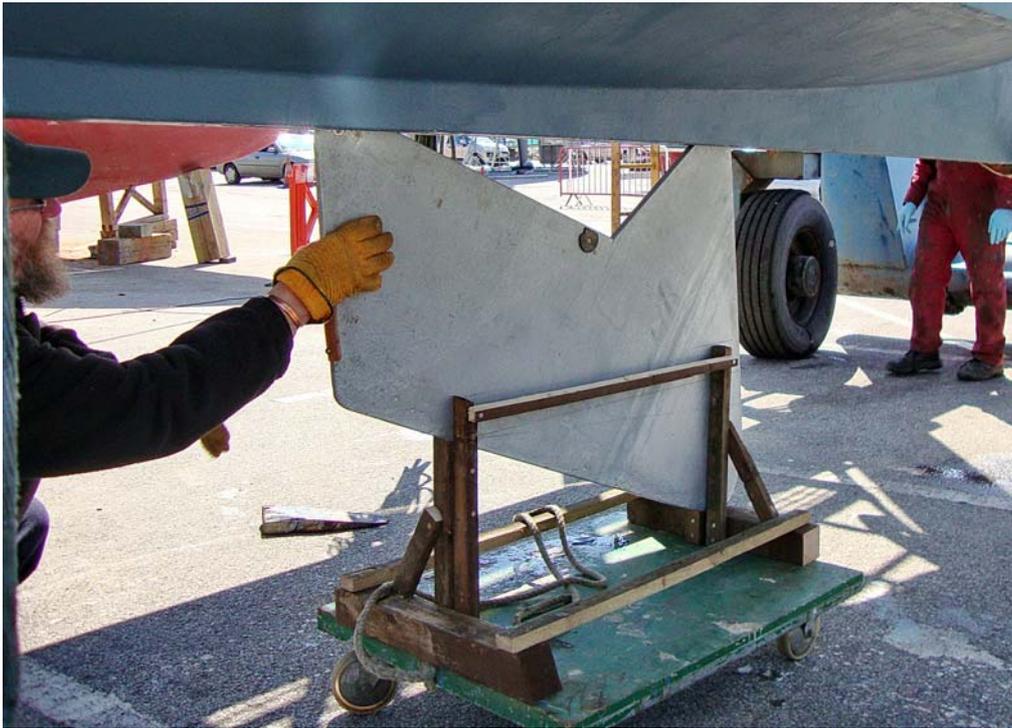
**Fig 20: Lower away - fore & aft plate tips enter the slot**

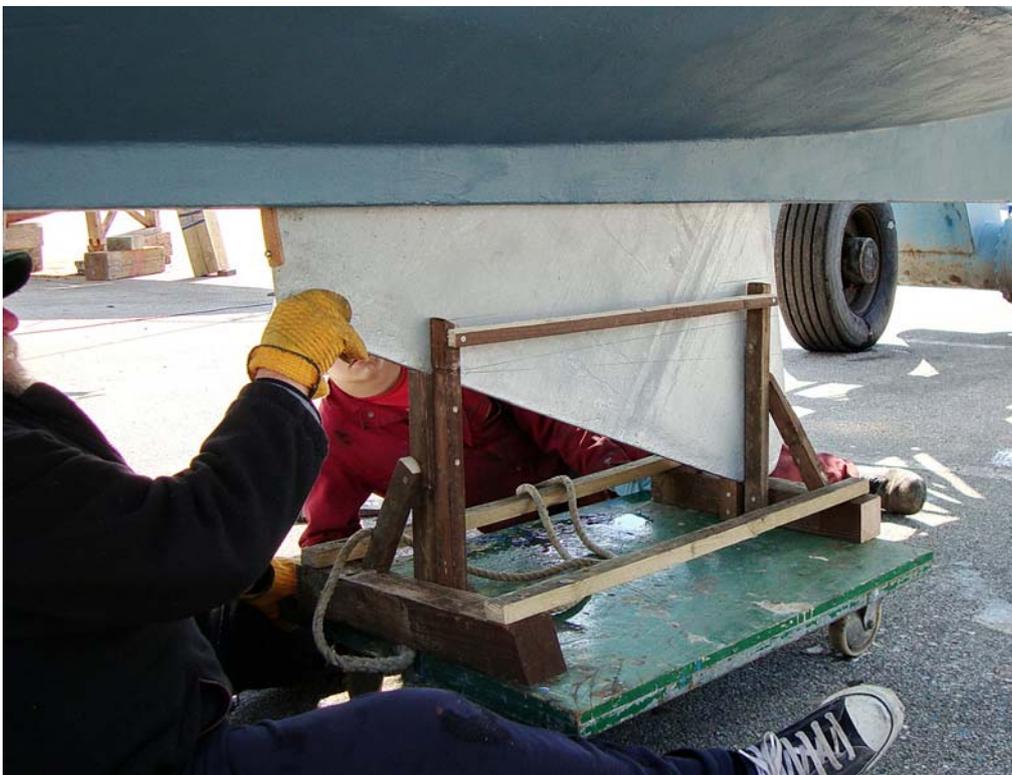
**Fig 21: Half way in - forward edge buffer just entering slot**

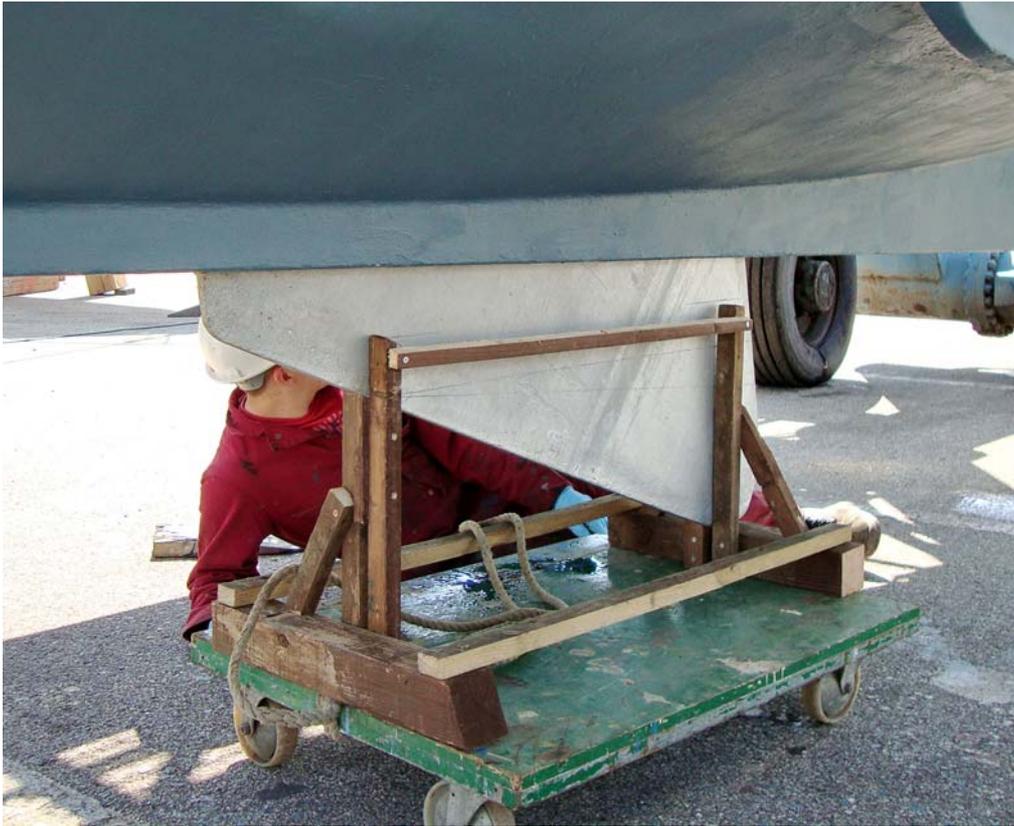
**Fig 22: Plate almost fully in**

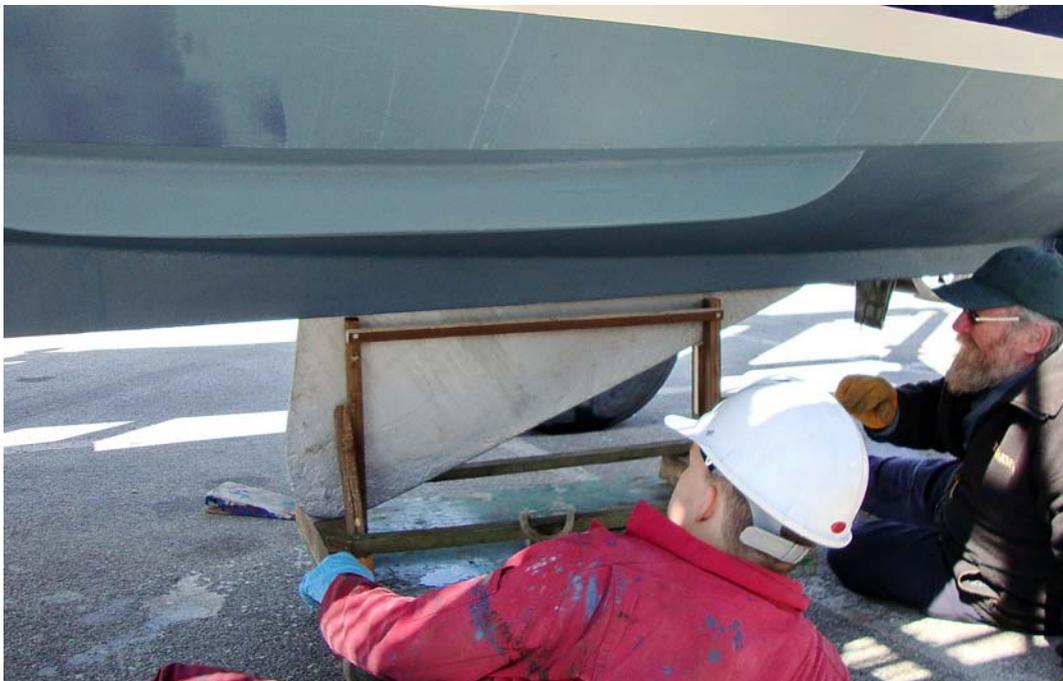
**Fig 23: Plate fully in & pivot bolt being fitted. Note small clearance between support frame uprights & underside of keel.**

Once the plate is well into the slot someone needs to be on board to attach the hoist rope and insert the pivot bolt, which should slide in easily provided all three holes are in line. Luckily, the loss of the forward line did not cause any difficulty and we obtained almost perfect alignment at the first try. With the bolt in place the centreplate was hauled up and down a few times to check all was running smoothly, then, after a final tighten of the bolt, *Winkle* headed for the water. Having heard tales of re-fitting taking up to two hours we were amazed to find that the whole installation had taken little more than 15 minutes from *Winkle's* first lift off the trailer. By the end we had attracted a fair number of onlookers, keen to know just what these mad Shrimper owners were up to. My particular thanks must go to Steve Kane (*Percy 264*) for acting as external coordinator (I was inside the boat during the latter stages) and Trevor Heritage (*Jessie May 882*), who was the official photographer. Following is a selection showing the re-fitting sequence.
