# Shrimper 19 Cutless Bearing Replacement

Jonathan Davies (Shrimper 19 Merriwinds 847) - March 2023

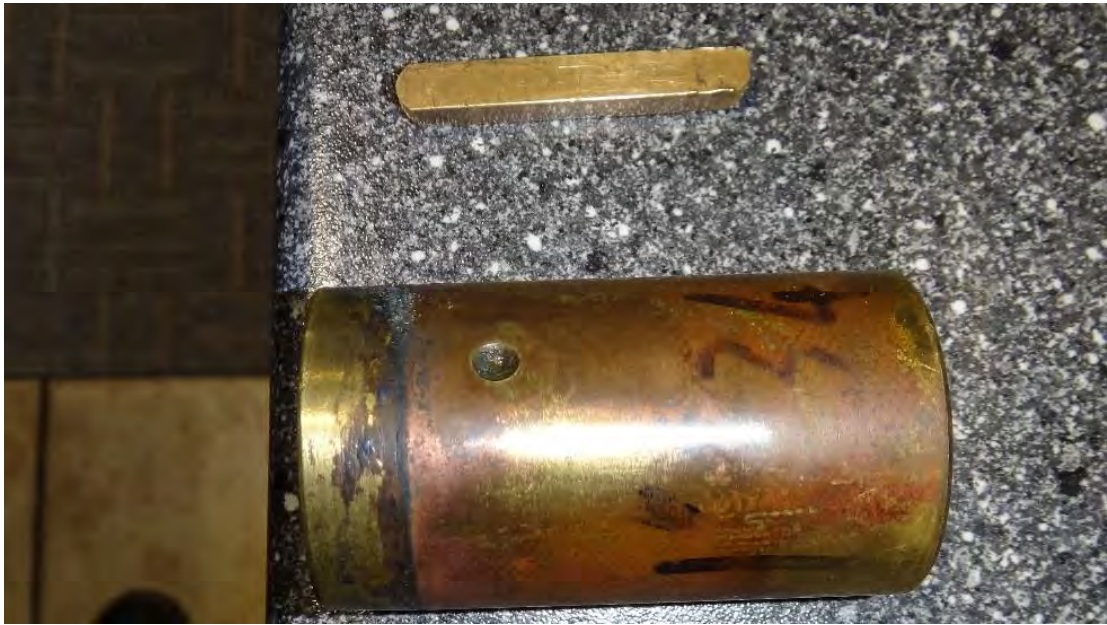
Photo 3

The bearing itself is held in place by one or two grub screws which screw through the GRP collar and into dimples drilled in the bronze. See photo 3 for an example of these. Once the area has been carefully cleaned of anti-fouling, the grub screws can easily be unscrewed. The bearing is a snug fit in the GRP skeg but there should be no problem with corrosion and, gripped with a suitable mole-grip or pipe pliers, it can be twisted and pulled out.

The new bearing can then be lubricated with soap and pushed over the shaft and into its housing. It needs to stick out enough to be able to grip it for subsequent removal. Use a punch through the grub screw holes to mark the centres of where the dimples need to be drilled. The bearing is then removed for drilling before being slid back into place. The drilling has to be quite accurate and obviously not too deep. Replacement of all the other parts is now straightforward.
