Shrimper 19 Cutless Bearing Replacement

By Jonathan Davies, Shrimper 847 *Merriwinds* (March 2018)

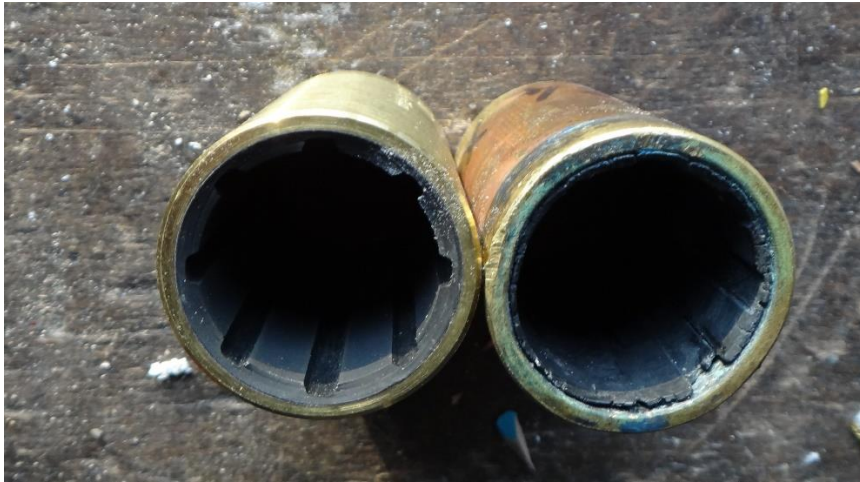
This bronze tube with a grooved rubber insert supports the end of the prop shaft and absorbs the lateral thrust from the propeller. Out of the water it is easy to examine, and if there is more than about 1mm of play allowing the shaft to noticeably 'clonk' sideways then it probably needs replacing. Photo 1 shows a comparison between a new bearing and a well-worn example with the grooves in the old, hardened rubber almost completely worn away. Left for much longer this old bearing would have allowed metal to metal contact and damaged the prop shaft. On our boat with this bearing there was always a rattle from the propeller under load.

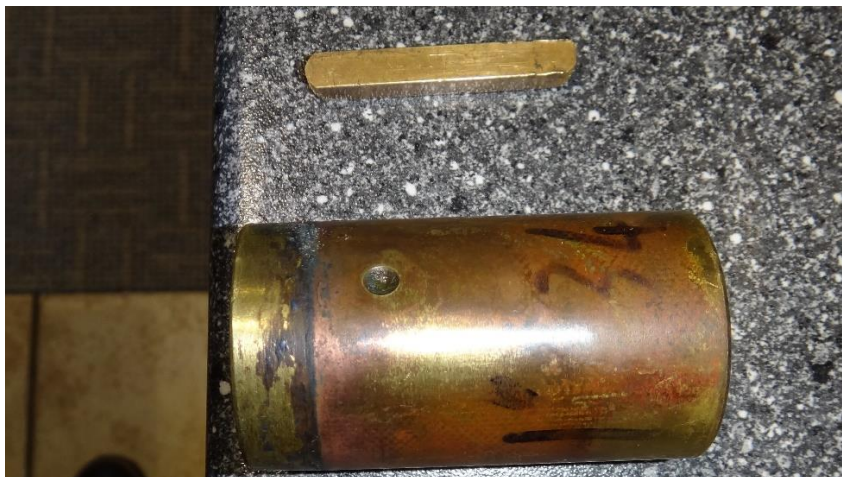
Photo 3

The bearing itself is held in place by one or two grub screws which screw through the GRP collar and into dimples drilled in the bronze. See photo 3 for an example of these. Once the area has been carefully cleaned of anti-fouling, the grub screws can easily be unscrewed. The bearing is a snug fit in the GRP skeg but there should be no problem with corrosion and, gripped with a suitable mole-grip or pipe pliers, it can be twisted and pulled out.

The new bearing can then be lubricated with soap and pushed over the shaft and into its housing. It needs to stick out enough to be able to grip it for subsequent removal. Use a punch through the grub screw holes to mark the centres of where the dimples need to be drilled. The bearing is then removed for drilling before being slid back into place. The drilling has to be quite accurate. Replacement of all the other parts is now straightforward.
