# Shrimper 19: Modification to Centreplate Sheave Mounting

Kevin Collins, No. 369, *Purple Haze*

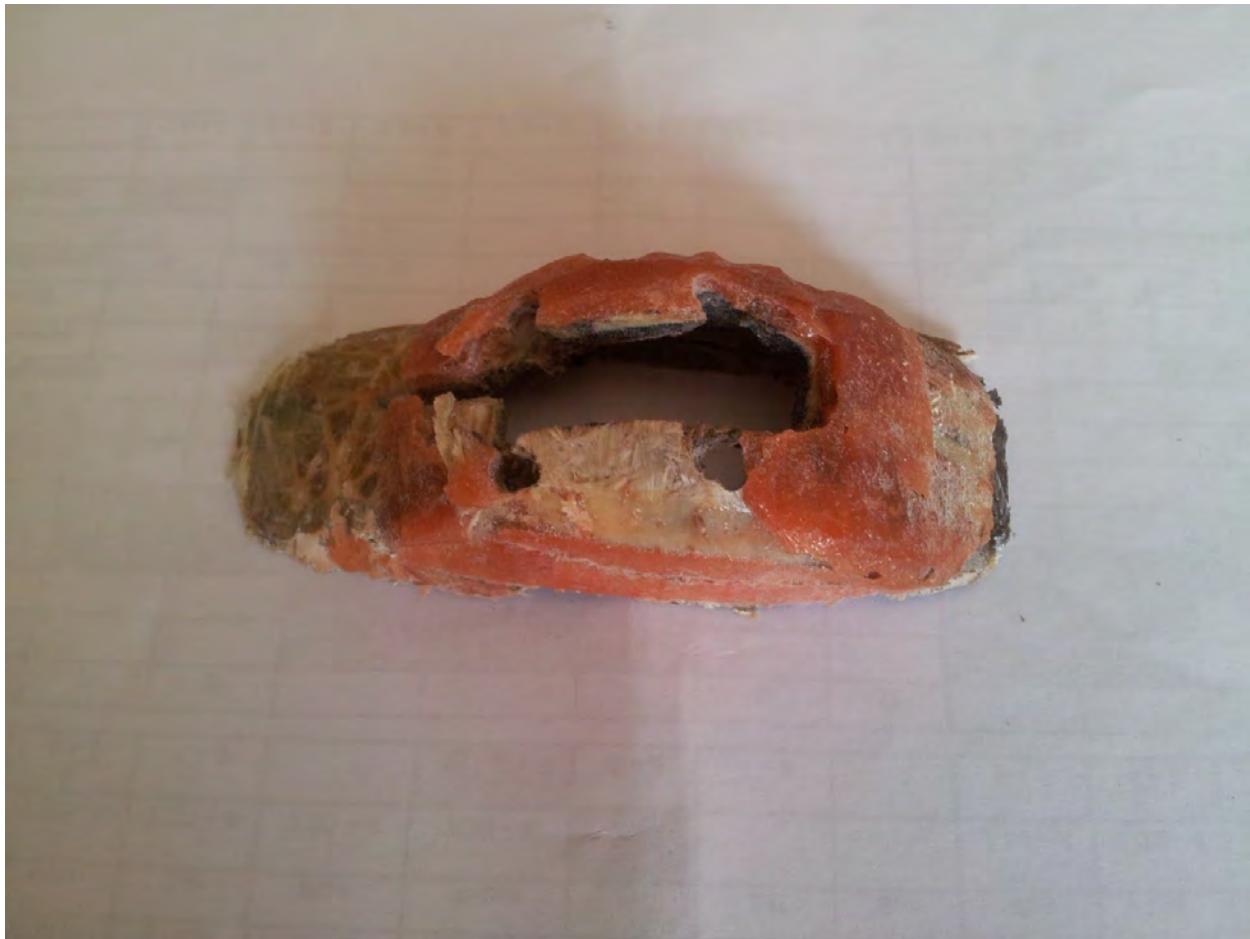
Fig 1 Original Sheave Mounting

The previous owner had already substituted 3 mm Dyneema for the stainless steel wire but the top of the keel box was in poor condition making it impossible to mount the sheave securely (Fig 1). The 3mm rope kept jumping the sheave and partly sawing its way through the keel box before breaking.

To solve the problem I decided to cut off the top of the keel box and make a new housing from hard wood.

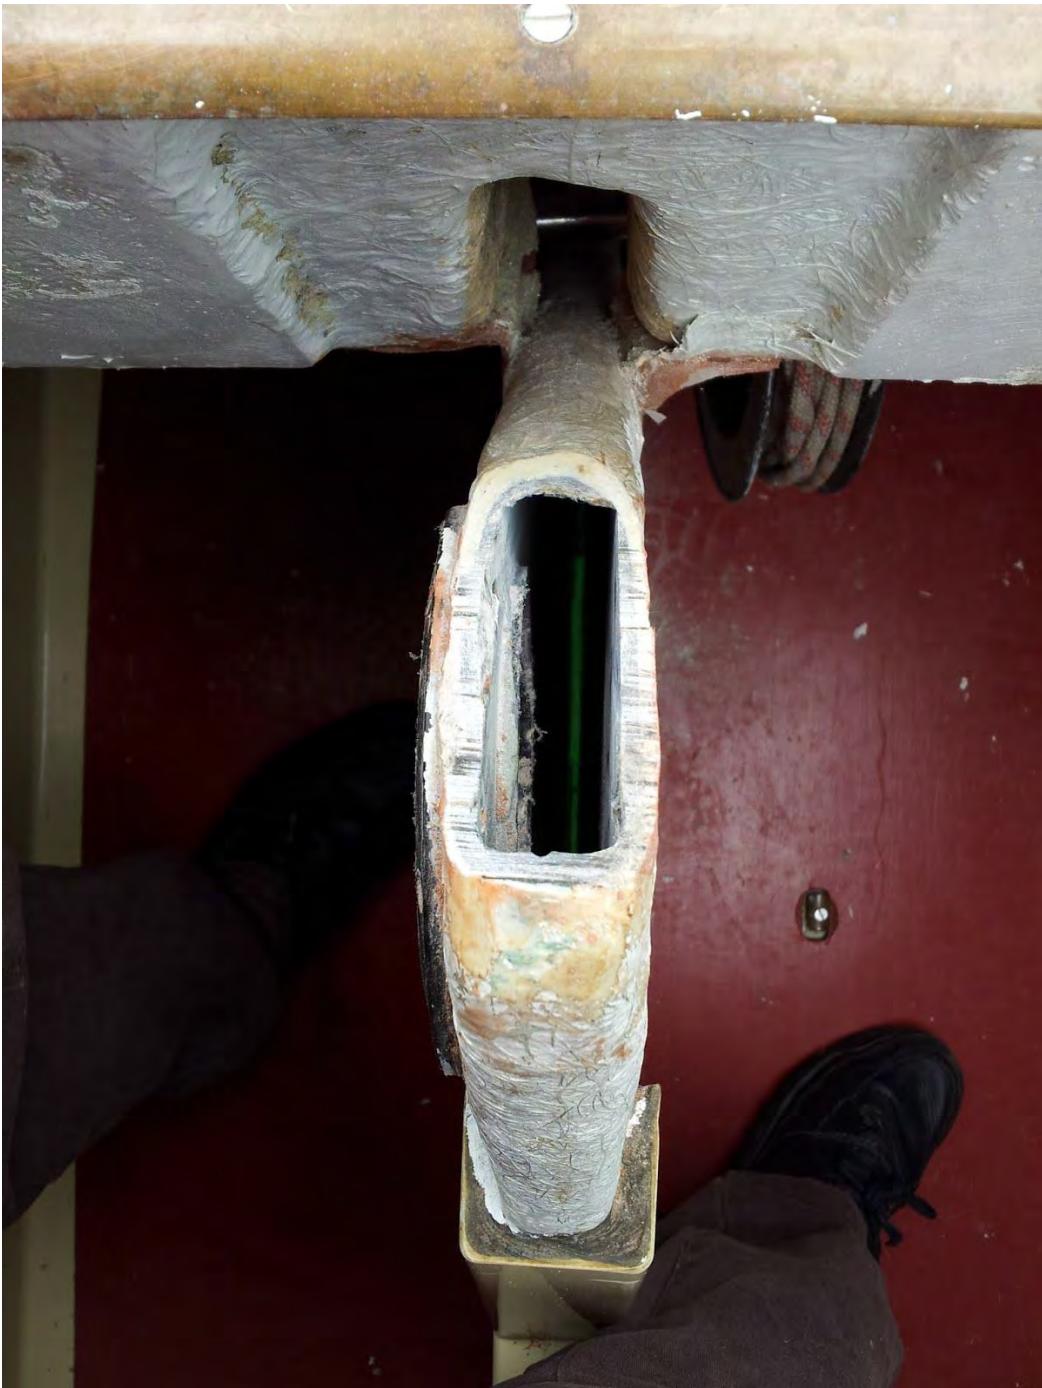
Fig 2 Keel box with top removed

Figures 2 and 3 show the keel box with the top piece sawn off. I subsequently faired the cut surface flat using a wood rasp..

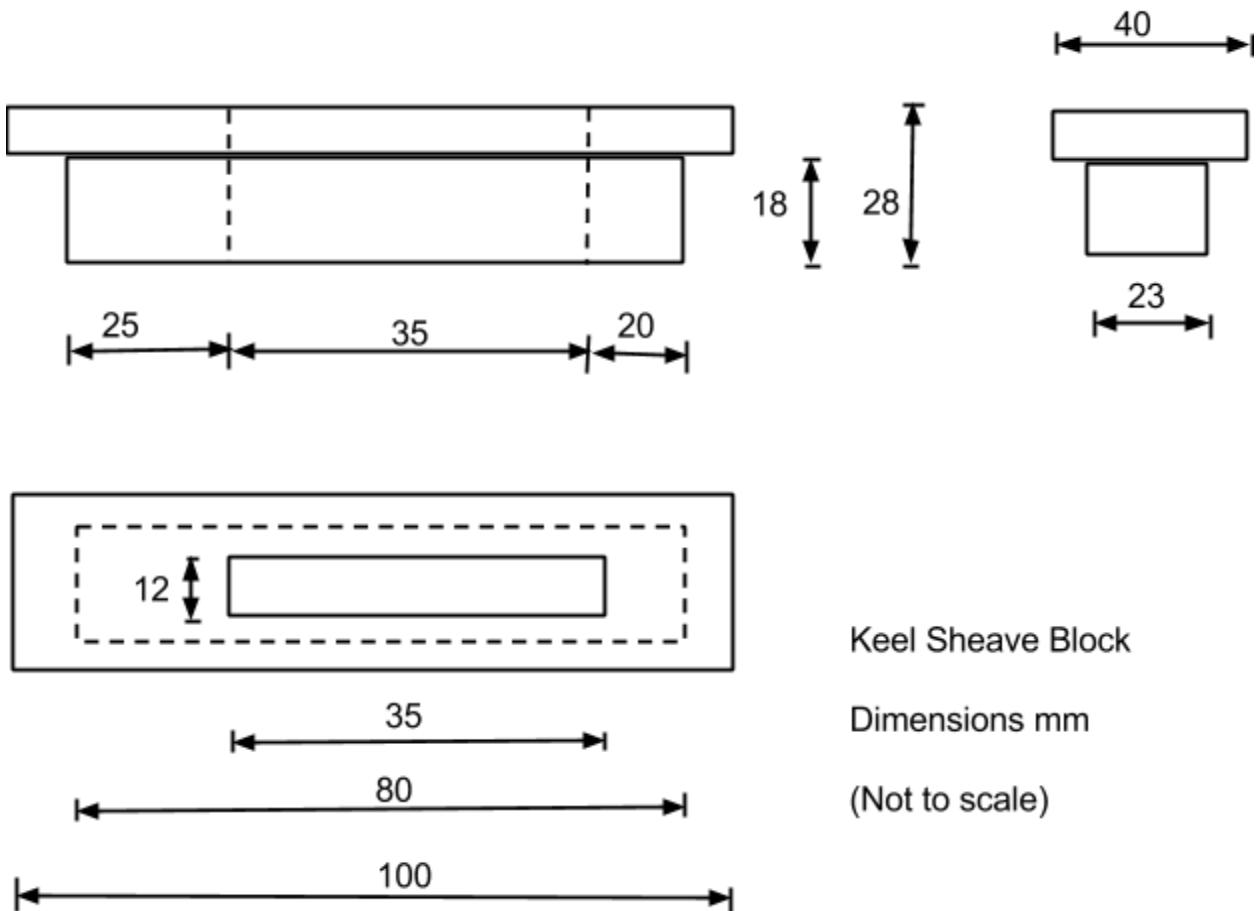
The new sheave housing dimensions were mostly dictated by the size of the opening in the keel box. The drawing is shown below with photos in Figures 4-7. I assembled it using waterproof "Gorilla Glue" (Figure 8) and added an eye and a groove to keep the rope in the sheave.

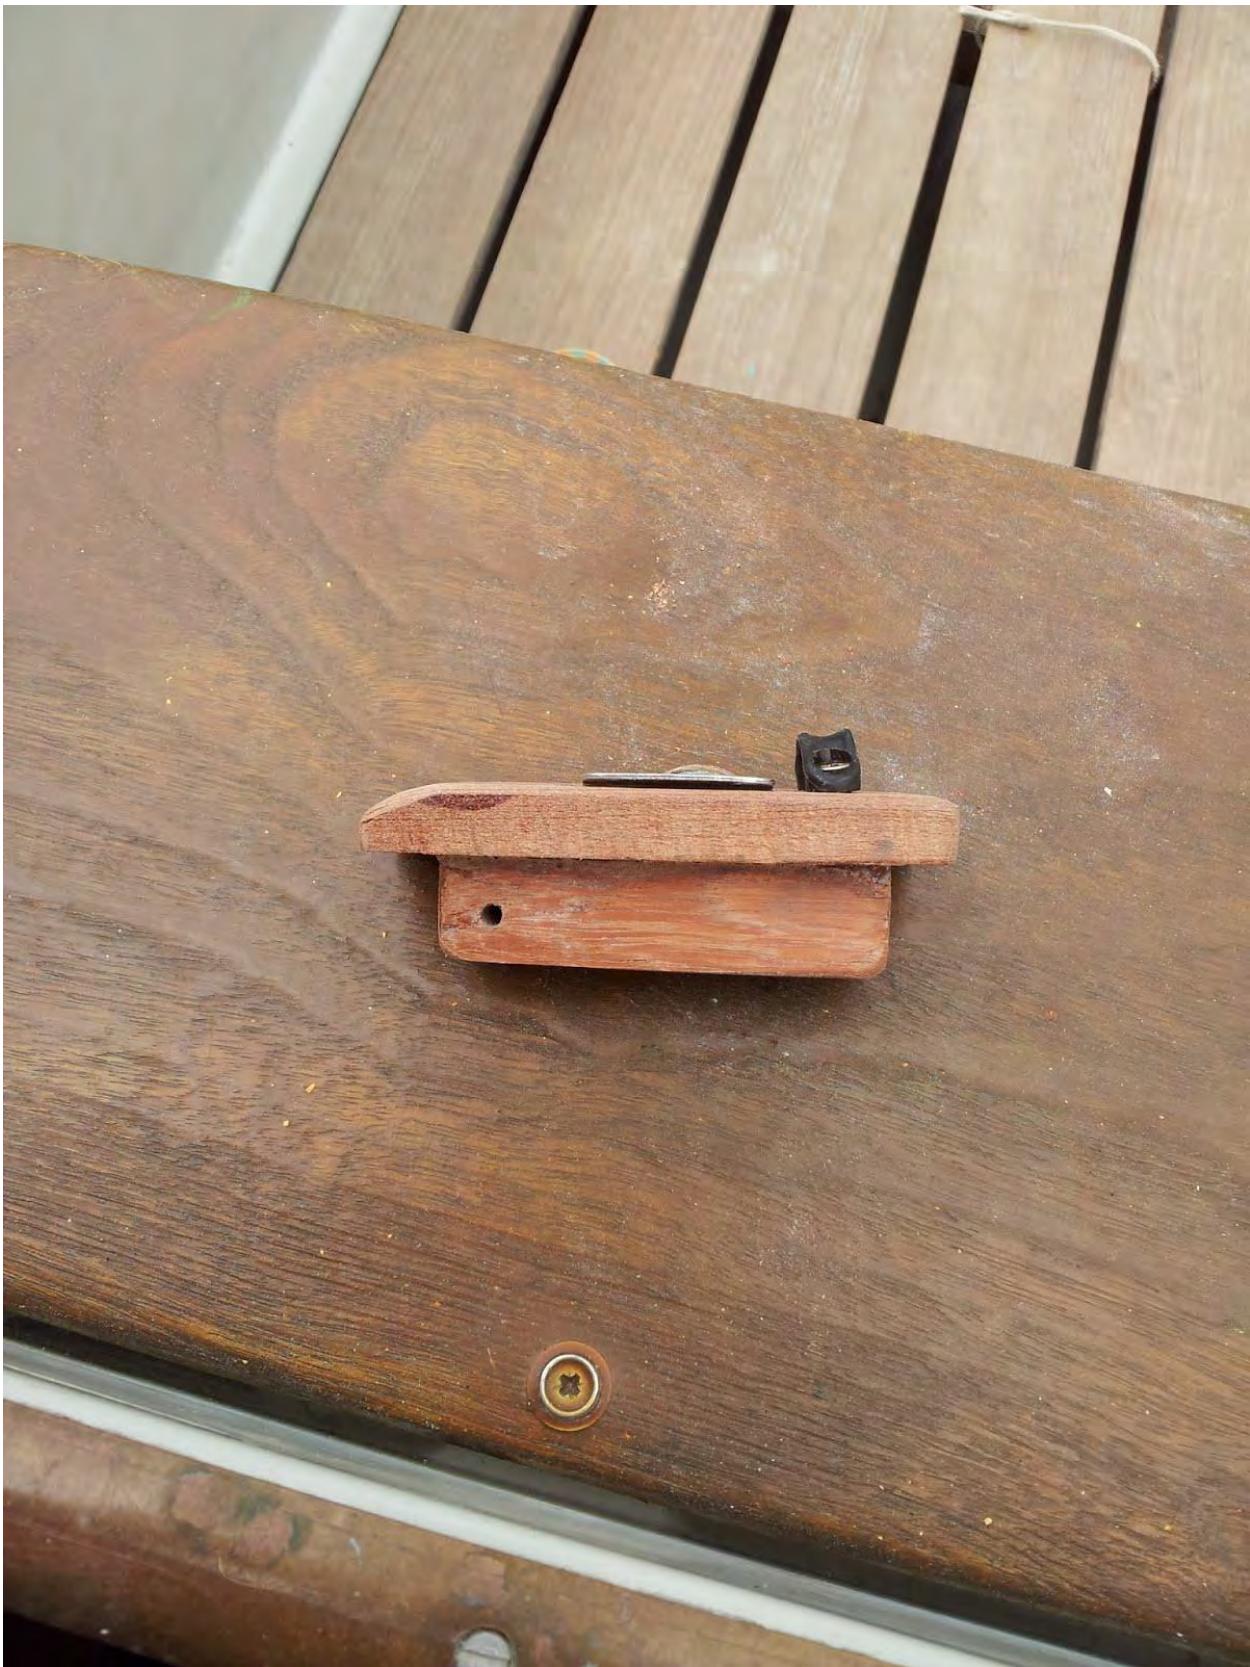
Fig 6 Side View showing mounting screw hole.

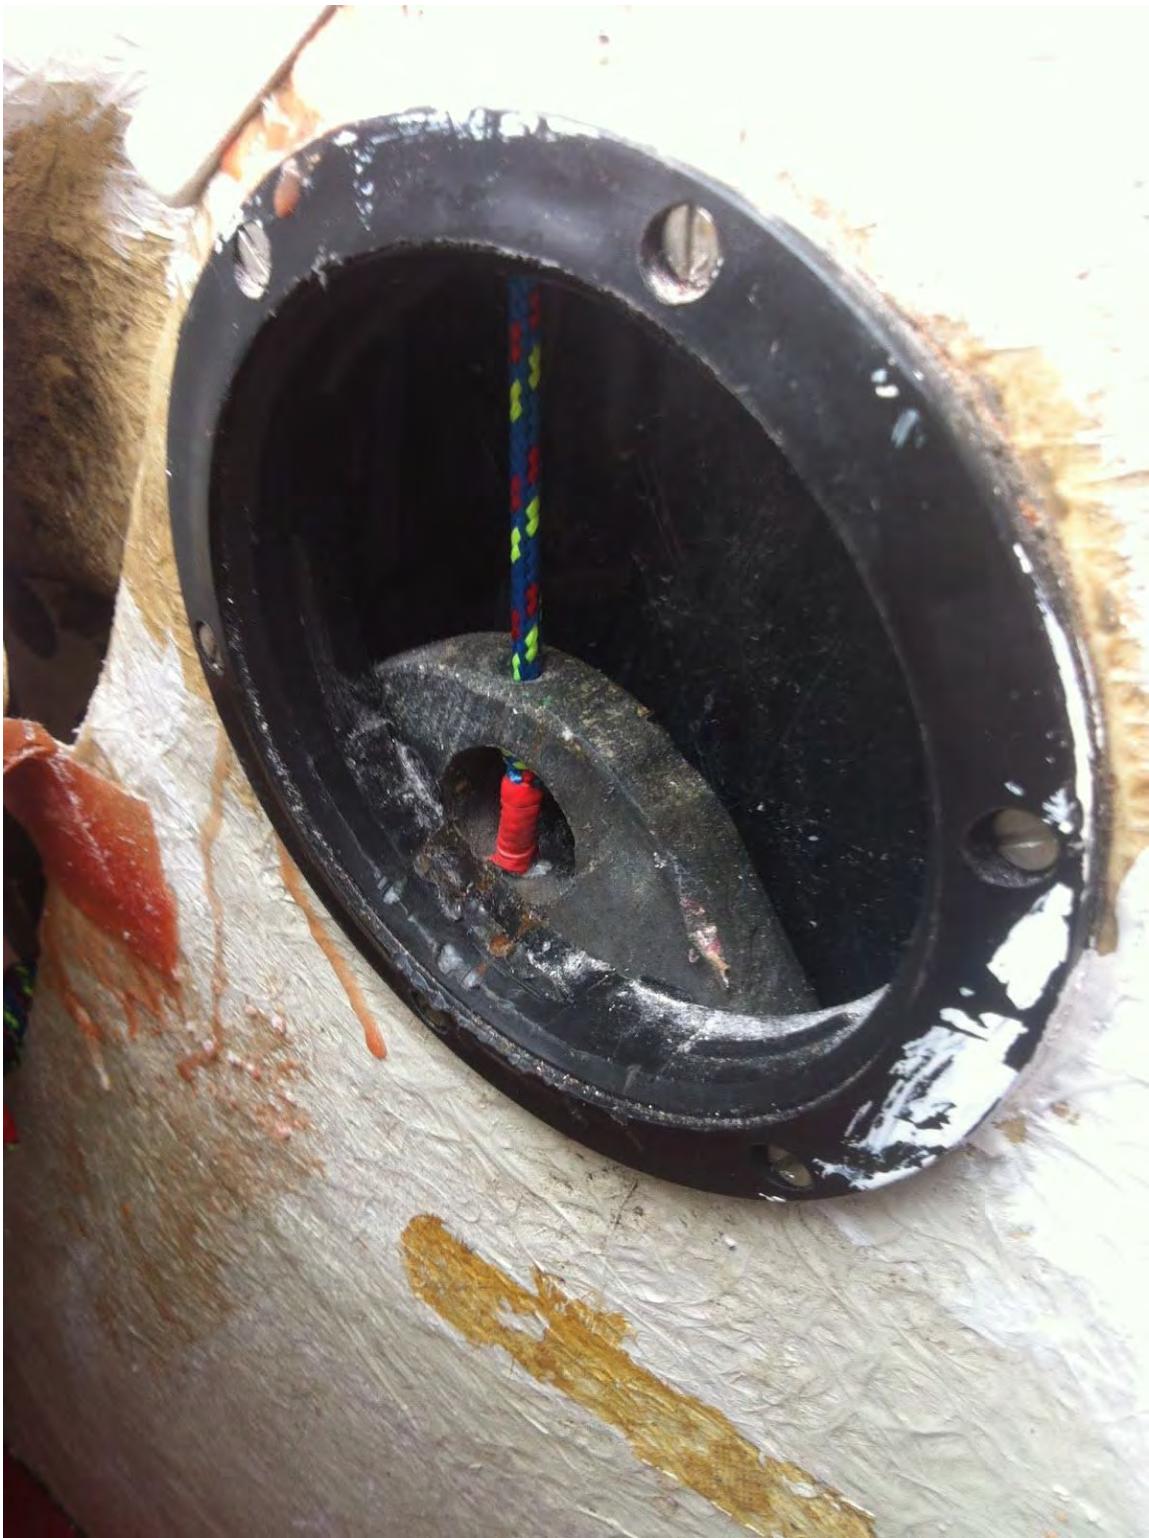
I ran the boat up on to a beach to complete the job. One bonus was being able to access the top of the plate and using a cobalt drill bit held in a small vice grips, I was able to open the hole up enough to take 4 mm Dyneema instead of 3 mm (Fig 9). A round needle file would have been more suitable still.

Figure 9 4 mm Dyneema threaded through

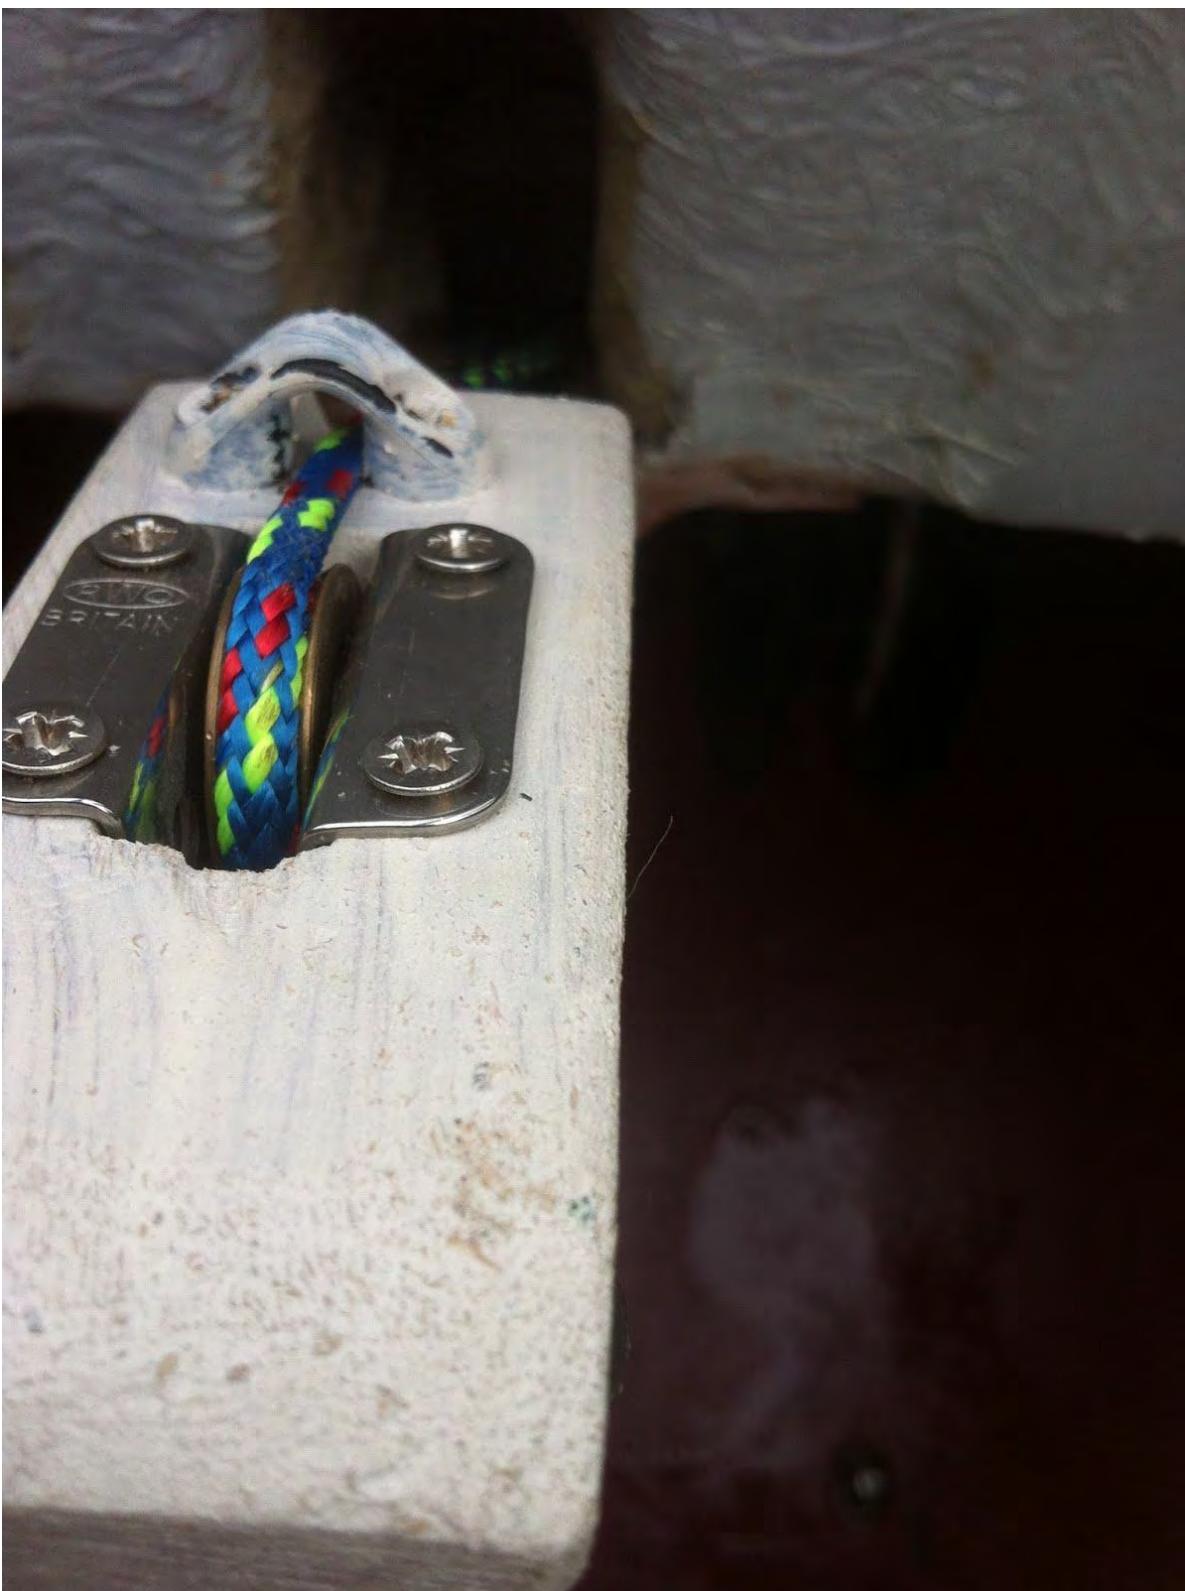
Figure 10 shows the completed job.

Figure 10 Close up of sheave mounting (painted)
