Shrimper 19 Cutless Bearing Replacement

Jonathan Davies (Shrimper 19 Merriwinds 847) - March 2023

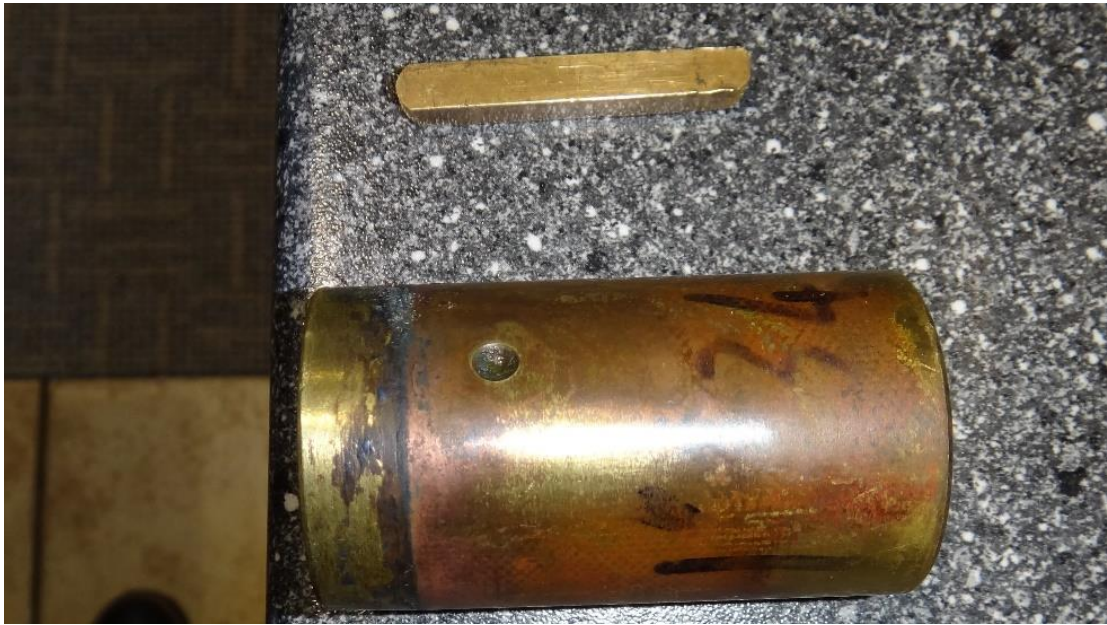
Photo 3

The bearing itself is held in place by one or two grub screws which screw through the GRP collar and into dimples drilled in the bronze. See photo 3 for an example of these. Once the area has been carefully cleaned of anti-fouling, the grub screws can easily be unscrewed. The bearing is a snug fit in the GRP skeg but there should be no problem with corrosion and, gripped with a suitable mole-grip or pipe pliers, it can be twisted and pulled out.

The new bearing can then be lubricated with soap and pushed over the shaft and into its housing. It needs to stick out enough to be able to grip it for subsequent removal. Use a punch through the grub screw holes to mark the centres of where the dimples need to be drilled. The bearing is then removed for drilling before being slid back into place. The drilling has to be quite accurate and obviously not too deep. Replacement of all the other parts is now straightforward.
