Shrimper 21 Floor Removal

By Jon Davies – S21-36 *Merriwinds*

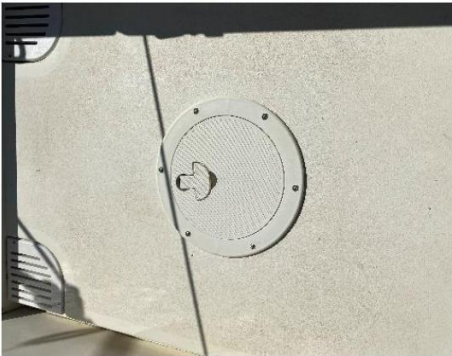
The Shrimper 21 has two important components hidden under the cockpit floor. First there is the fuel tank which, unlike a S19, uses a built-in electrical fuel gauge and has no dip stick. If there is a problem with the gauge there is no way of knowing how much fuel you have. The tank might also need cleaning. The other important component is the Tides Marine water-lubricated propeller shaft seal. This, it appears, in a Shrimper has a life of about six or seven years before it can start dripping and eventually need replacement. So, two items which require access for maintenance. Surprisingly however, on a Shrimper 21 there is no designed built-in access to either of these components. To get at them the sealed-in floor must be removed, which is a major job. In desperation, to replace a leaking propeller shaft seal some owners have cut an access hole for a hatch in the floor, but this solution will obviously ruin any teak deck fitted.

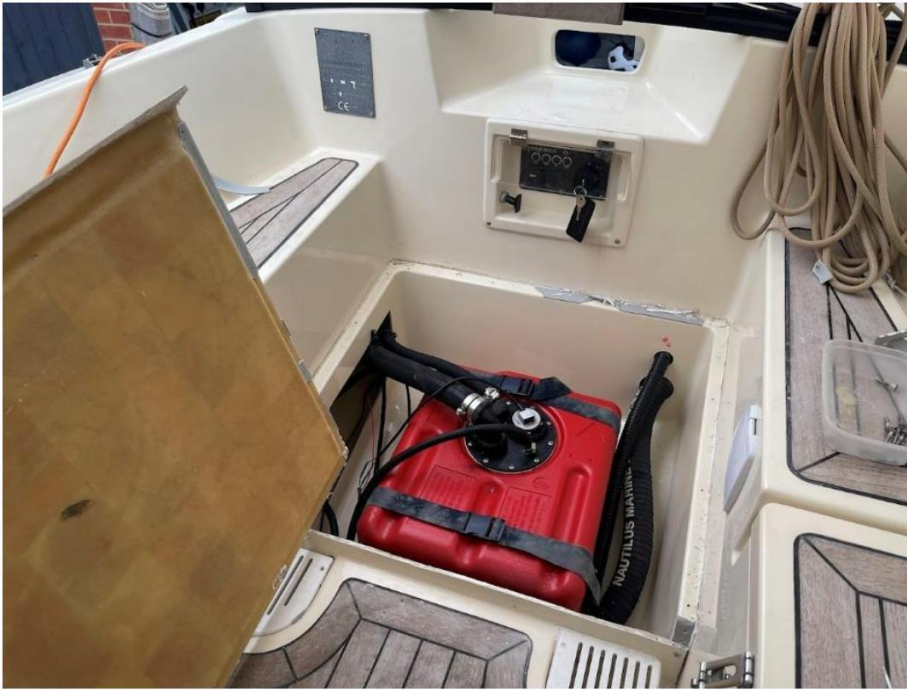
Now we start to loosen the rear section. The floor is seated on some soft butyl marine sealant tape which is not double-sided but can in places hold the two fibreglass edges together. The bead of silicone will also not have been cut everywhere and will need some prising apart. Starting at the vertical corners I used a small right-angled pointed scraper tool like a bent screwdriver to initially prise away the corner edges without using so much force that there was a danger of any of the fibreglass snapping off. Slowly the silicone and any adhesion on the tape inside will yield, giving more and more room to get a purchase. Be patient and, using screwdrivers as wedges, slowly the front end will lift until the floor eventually peels way from its seating. The rear section can now be removed.

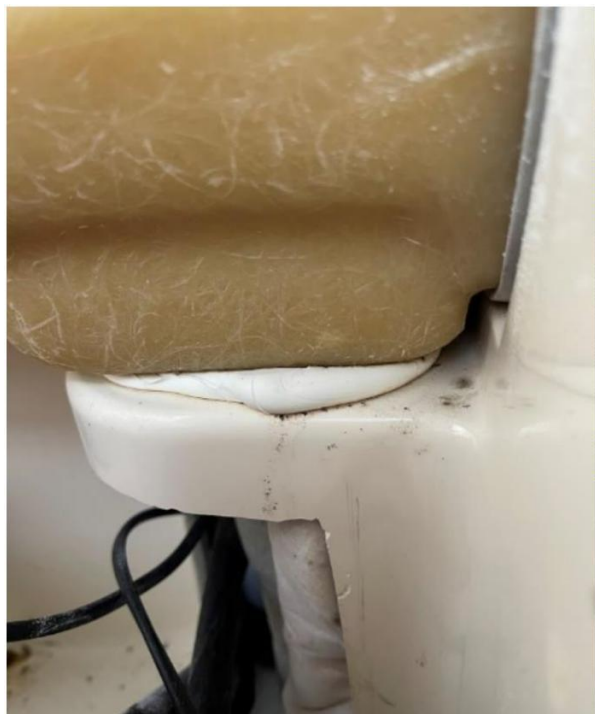
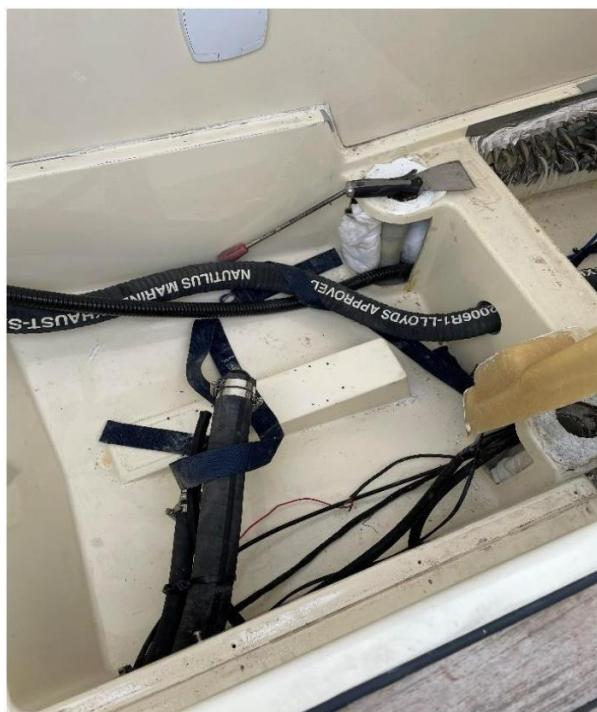
The view from the back showing one of the flattened doughnuts that need to be cut, and the view once the floor was out showing the scraper I used as a very fine chisel (now very battered) Something a bit narrower than the one I used might be easier.

You can now begin the main floor removal. (Note that it is not necessary to remove the gear lever or the cover for the keel raising line at the front). The hardest problem to solve is separating the cockpit drain holes which are bonded to the lower moulding with two doughnuts of heavy-duty mastic. These are accessible from the fuel tank space. The mastic is quite tough (I did this job when it was 7c outside, perhaps on a warmer day it might be easier). The way I did it, (and there might be better ways), was to use a heavy-duty sharpened scraper and hit it hard with a lump hammer forcing it into the mastic between the two mouldings. It eventually cut through but it was quite hard work. Once you have separated the drain holes you can use a small jemmy to lever up the rear floor, again bit by bit, allowing the silicone to slowly

separate. On my boat, once the front and rear were free the rest reluctantly peeled away and the floor could be manoeuvred out. It is not too heavy.

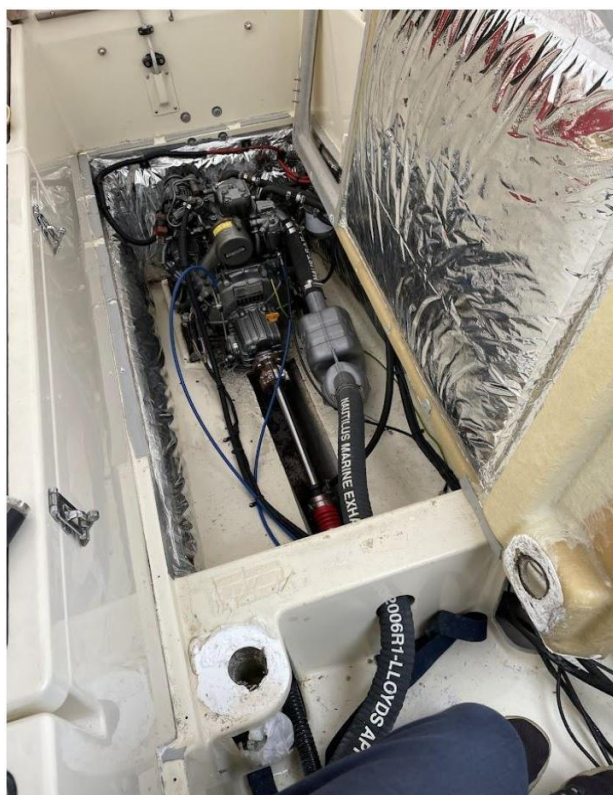
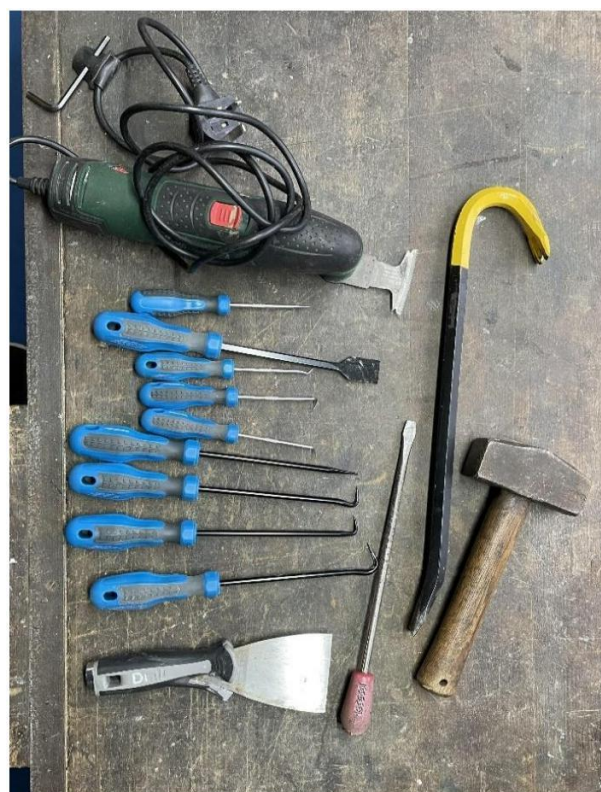
The front floor finally up. It was not as heavy as expected and can be carefully lifted out of the boat. Note the butyl tape which stuck partly to both mouldings and came away in different pieces. You can see the separated doughnuts. There is now good access to the propeller shaft and its shaft seal assembly. On the right is a selection of tools used.
