Mast Maintenance & Repair

By Keith Thatcher, Shrimper *Winkle* (144), SOA Technical Web Sec (March 2011)

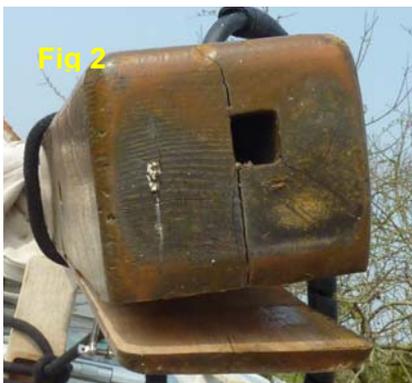
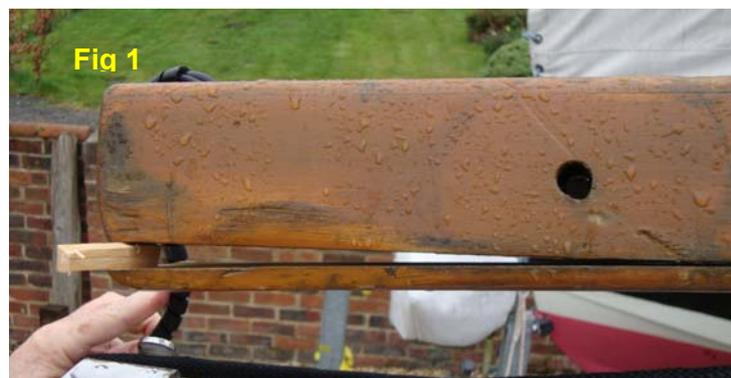
Re-gluing a severely delaminated joint is not advisable and, in most cases, impossible without taking the whole assembly apart. Not only do you have the difficulty of getting a thixotropic liquid into a narrow crack, but the adhesive needs to penetrate the wood pores to bond effectively and any old hardened glue effectively seals the surface. It is therefore important to seek professional advice when determining the repair potential for any glue line fault, particularly one as bad as that shown in Figs. 1 & 2. However, small areas of joint separation, similar to that shown in Fig 3, can be repaired, if not too deep, by cleaning out the damaged area to sound wood using a router and gluing in new timber. A typical repair of this type is shown in Fig. 4.
