# Mast Maintenance & Repair

By Keith Thatcher, Shrimper *Winkle* (144), SOA Technical Web Sec (March 2011)

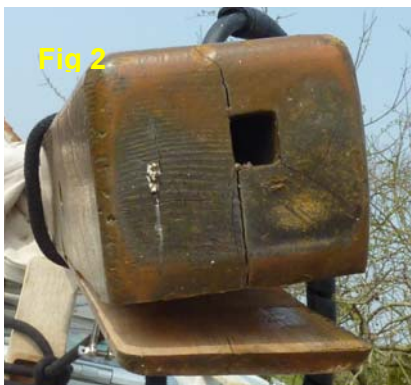
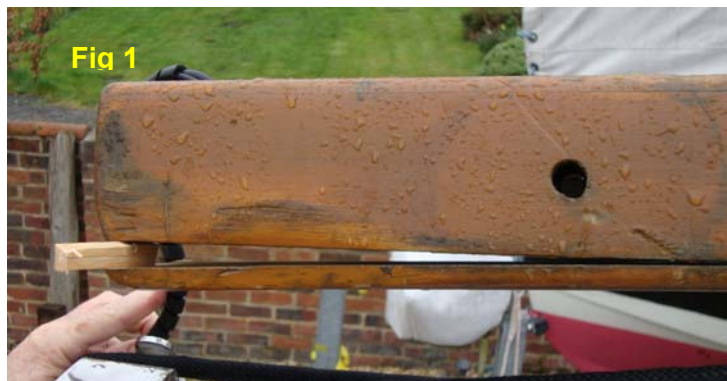
This winter the Poole fleet has seen a spate of mast problems, from rot to failure of the glue joints, so here are a few thoughts to help prevent any nasty surprises come fit-out time.

Faults are much easier to remedy if caught early, so regular mast inspection is essential. Owners who de-rig their boats the end of each season are well advised to include a quick condition check as part of their annual lay-up procedure, but even if you are one of those who leave your boat rigged, it pays to give the mast a once-over every two or three years so that problems do not have a chance to build up. The occasional knock or ding in the coating as part of normal sailing is quite common and these obviously need to be repaired, but there are a couple of areas that warrant particular attention if lasting damage is to be avoided. These are the structural glue joints and the area around the mast band.

Re-gluing a severely delaminated joint is not advisable and, in most cases, impossible without taking the whole assembly apart. Not only do you have the difficulty of getting a thixotropic liquid into a narrow crack, but the adhesive needs to penetrate the wood pores to bond effectively and any old hardened glue effectively seals the surface. It is therefore important to seek professional advice when determining the repair potential for any glue line fault, particularly one as bad as that shown in Figs. 1 & 2. However, small areas of joint separation, similar to that shown in Fig 3, can be repaired, if not too deep, by cleaning out the damaged area to sound wood using a router and gluing in new timber. A typical repair of this type is shown in Fig. 4.
