Changing the Oil Pipes on an Inboard Shrimper

By Jonathan Davies, Shrimper 19 *Merriwinds* (847) – July 2023

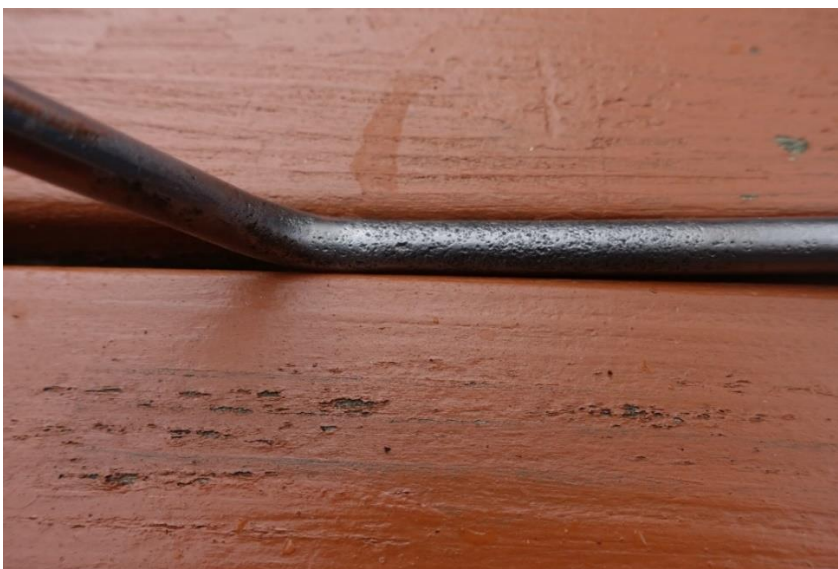
The photo shows the removed long pipe together with the tools I mainly used. At first sight it did not look too bad and I wondered if it was necessary to replace it yet. However, once cleaned back to bare metal with a wire brush, some quite deep pitting became more evident on the whole surface. The pipe could not be trusted for very much longer. In the eight years of my ownership the water pump has never been left to leak; perhaps the rust is just the result of 20 years exposure to sea air. The pipe has now been replaced with one made from stainless steel.

I obtained the stainless-steel replacement long pipe with washers from E bay for £99. The little supporting bracket was folded around it and I was relieved to see that it all fitted perfectly.
