## *Centreboard case distortion in Cornish Shrimper No. 124*

*Robin Whittle*

No 124: Bumble Chugger (BC) was built in 1983.

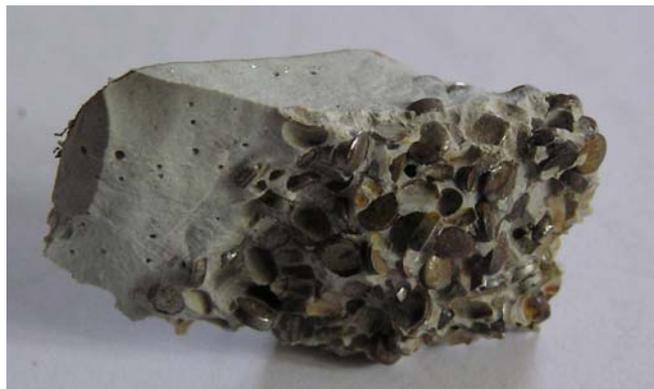
I discovered from discussion with Cornish Crabbers Ltd (now Select Yachts) that the ballast is made up of steel pressings set in a compound of slate dust and polyester resin. In BC each pressing is about 3 mm diameter and 1 mm thick. Several million of these pressings are used to make up the volume of ballast

In order to understand my train of thought it is necessary to note that when sailing to windward the centreboard exerts large forces on the centreboard case (especially in strong winds). These forces may be sufficient to cause a crack to form between the fibre glass wall of the centreboard case and the ballast. Once such a crack has formed it provides access to sea water and oxygen. This allows the steel pressings to start to rust.

Once this process starts it causes the pressings to expand creating enormous forces. These forces in turn cause the crack size to increase and allow more water and air to get in and the rusting increases and extends the crack further along the length of the centreboard case. As a consequence of this pressure the centreboard case distorts reducing the size of the slot in which the centreboard slides.
