Shiny Bright Again: Farécla Trials 2012

By Keith Thatcher, SOA Technical Web Sec (First published in *The Shrimper*, Autumn 2012)

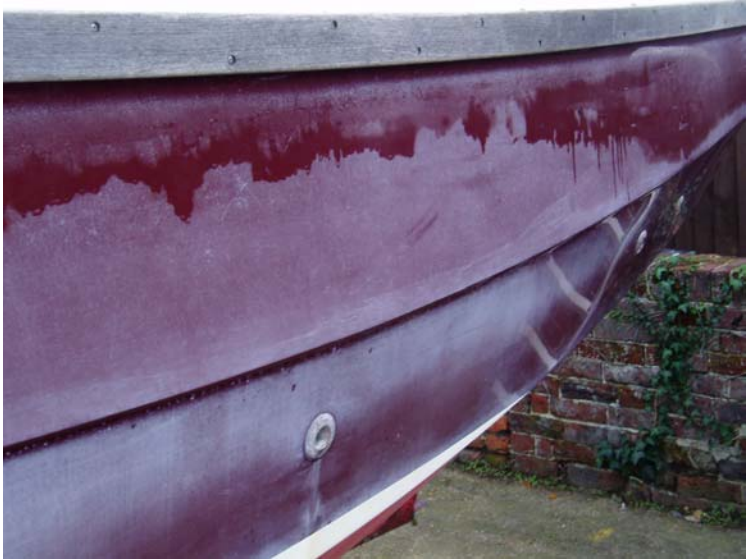
Hulls requiring Deep Cut

With the trial underway the Shrimper Topside Team of Richard Pottinger, Keith Thatcher (SOA) and David Taylor (Farécla Marine Industrial Business Manager) started looking into the process specifications to suit different types of hull deterioration. When Farécla products were first introduced to the SOA we had tried to provide a “one fits all” solution. It has now become evident that, in particular, bad oxidation requires a more aggressive approach, so for 2013 Farécla will be offering three processes, each aimed at a specific level of topside deterioration. **Deep Cut** is for a badly bloomed or oxidised surface – essentially a matt hull. A hull with **Moderate Blooming** would be patchy, say 50% dull but with some shine still remaining. The **Light Weathering** process is for owners whose boat still has most of its shine intact and who want to keep it that way – essentially a preventative process. The following photos are intended to assist owners in identifying into which category their boat falls.

If in doubt, always go for the next more aggressive process. Experience over the past three seasons has shown that removing too little of the oxidised surface generally allows the blooming to return quite quickly, often in a matter of weeks. One benefit of Farécla products is their ability to “self limit” the amount of material being removed as the abrasive degrades in use. Although some of the coarser compounds, particularly Profile 100, can seem aggressive, none can do any significant damage if used sensibly. More information will be available on the website once the processes have been finalised.

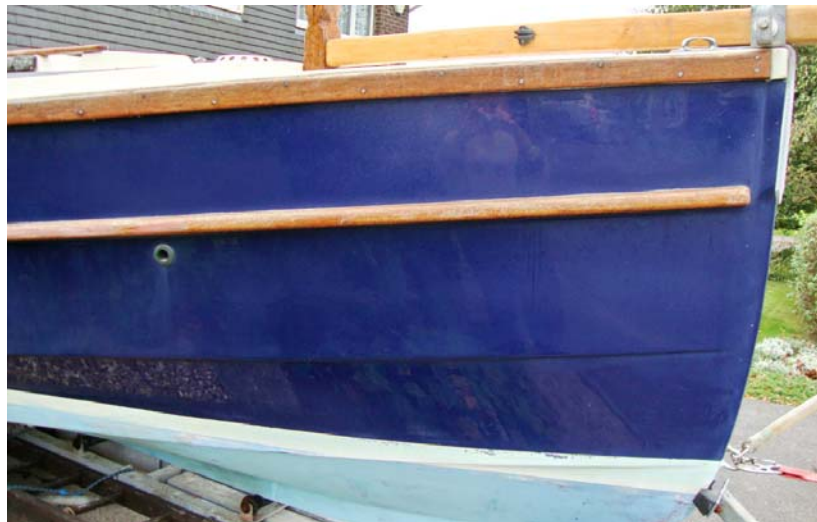
Hull with Moderate Blooming

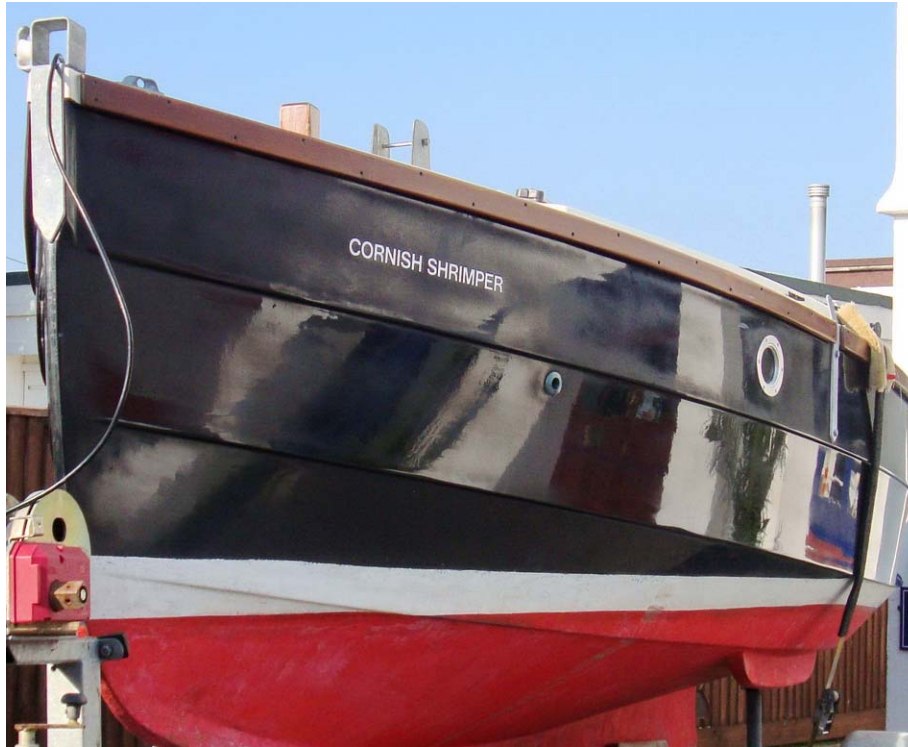
Hull with Light Weathering
