Painting The Hull

By Roger Lowe, Shrimper 618 (2006)

Roger Lowe has recently (2006) repainted the hull of "Curlew", Shrimper 618. His notes outline the steps taken, plus a few suggestions for making things easier and may help others decide whether to paint or not.

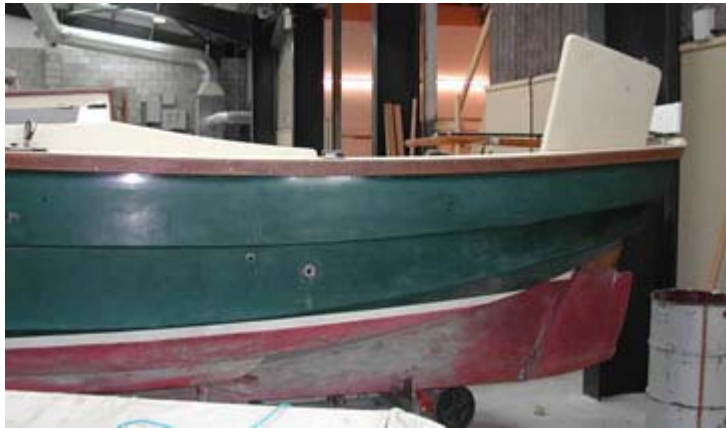
Curlew was bought in 2004, she had been neglected for a couple of years as you can see:

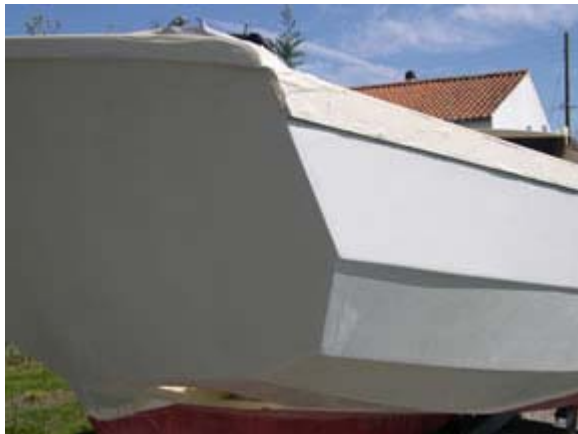
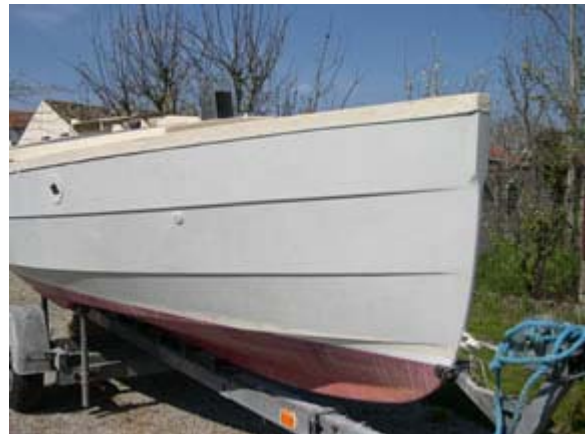
The following photos show the white hull at epoxy stage. I had removed the rubbing strake to re varnish, simple but laborious as there are loads of screws. The trick in painting is to have 2 of you doing it – one rolling, one tipping off. I did it on my own and it is harder – but achievable. If hit hard, as my accident proved, the paint doesn't flake, and I was impressed by the top coats' adherence to the epoxy primer and the epoxy to the gel coat.

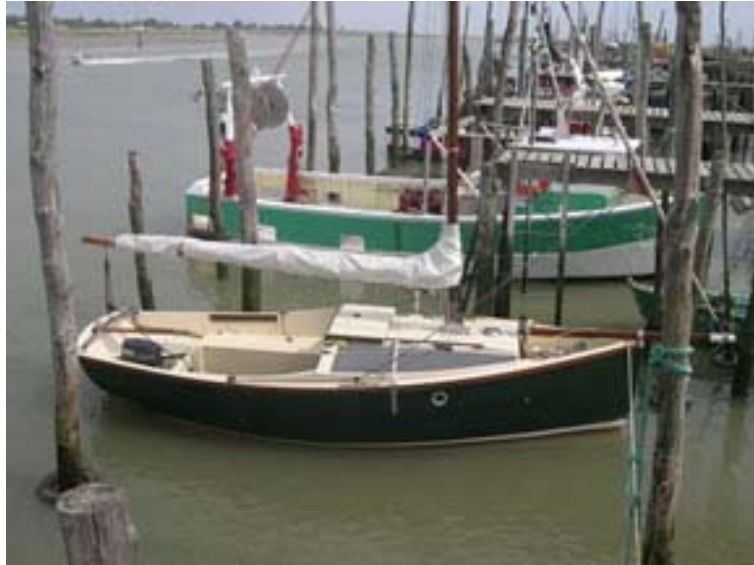
Curlew went afloat in May 2005, and is kept in a "poled" mooring where she gets some knocks every now and again. Roger's views are: " I think she looks a lot better, time will tell on the longevity of the colour but the guy from Blakes said at least 4-5 years. Like "%*! to a blanket springs to mind. Do it again? Yes but in a shed with 2 painters and I would thin the epoxy and top coat a little more to get a better "Flow" finish. I can see my face in it, but with my visage I am not sure that's a recommendation."

The finished article
