Painting The Hull

By Roger Lowe, Shrimper 618 (2006)

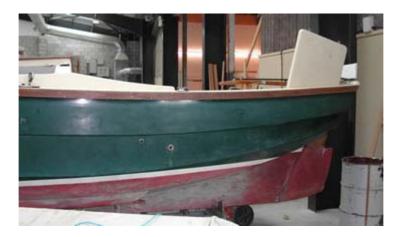
Curlew was bought in 2004, she had been neglected for a couple of years as you can see:

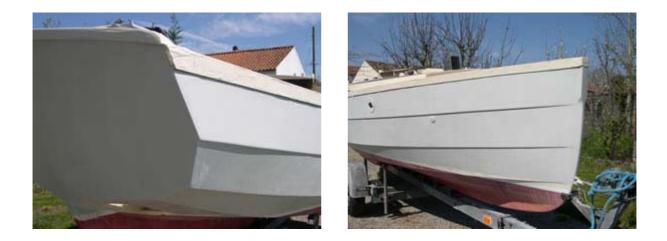
The following photos show the white hull at epoxy stage. I had removed the rubbing strake to re varnish, simple but laborious as there are loads of screws. The trick in painting is to have 2 of you doing it – one rolling, one tipping off. I did it on my own and it is harder – but achievable. If hit hard, as my accident proved, the paint doesn't flake, and I was impressed by the top coats' adherence to the epoxy primer and the epoxy to the gel coat.

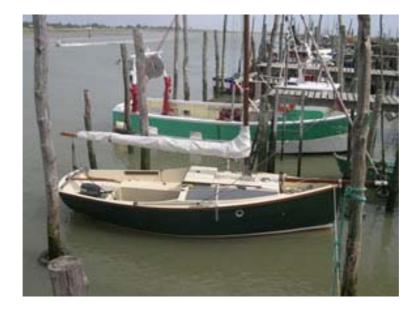
The finished article

Curlew went afloat in May 2005, and is kept in a "poled" mooring where she gets some knocks every now and again. Roger's views are: " I think she looks a lot better, time will tell on the longevity of the colour but the guy from Blakes said at least 4-5 years. Like "%*! to a blanket springs to mind. Do it again? Yes but in a shed with 2 painters and I would thin the epoxy and top coat a little more to get a better "Flow" finish. I can see my face in it, but with my visage I am not sure that's a recommendation."
