Pivot Bolts On Rudders & Centreplates

By Mike Broad, Shrimper 500 (*Damzelfly*), (Spring 2003)

More on bolts!

By Mike Broad, Shrimper 500 (*Damzefly*) (Winter 2004)

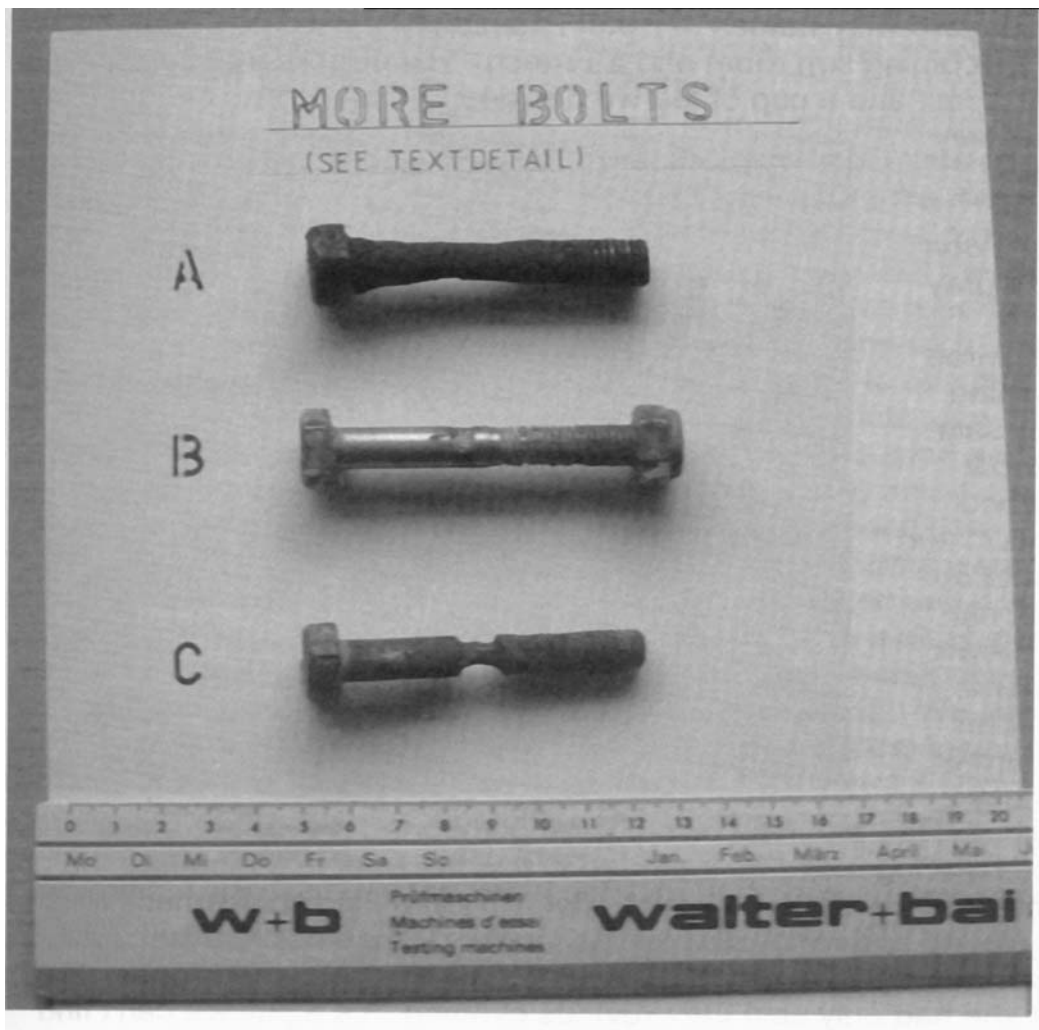
I was surprised that reader Paul Rich (Winter 2003 magazine) was disappointed to find that his boat's centreplate pivot bolt was still in good condition. Fortunately this is the "norm". Of the boats we checked locally, all but one was also in pristine condition. The rare exception is shown in the attached photo, marked (A). Nuff said.

Photo (B) shows an M10 stainless steel rudder pivot bolt. Interestingly, there is evidence of pitting on the diameter, due to the well-documented phenomenon of anaerobic corrosion of some stainless steels. Nothing to worry Shrimper owners, even in our "ultra saline" waters...!

Photo (C) shows a badly worn M10 galvanised steel rudder pivot bolt from an older Shrimper (before stainless steel fittings became standard). The deep wear groove is very clear - fortunately the owner discovered the problem whilst ashore. Replacement of the old galvanised steel rudder plates, bolts, hangings etc., with the later stainless variety seems to cure the problem. Although our Shrimpers are very sturdily constructed, moving items will not last forever, so regular maintenance should be a key part of boat ownership.
